Access Compliance Report

Public Rights-of-Way

(Curb Ramps)

Intersection ID: 12983	Main Street: E_TRADE_ST	Cross Street: N_MYERS_ST	Location: N
ADA ID: ECA7EFE3751F	Ramp Type: Perp	Initial Pass/Fail: Pass	Overall Compliance: No
			Severity Score: 0.25

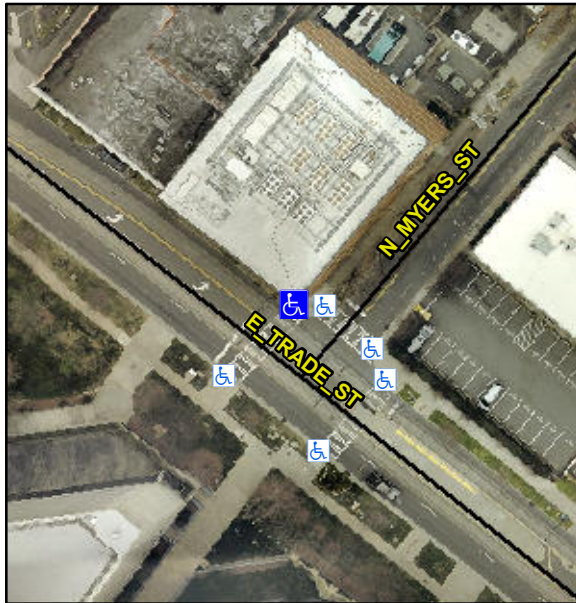
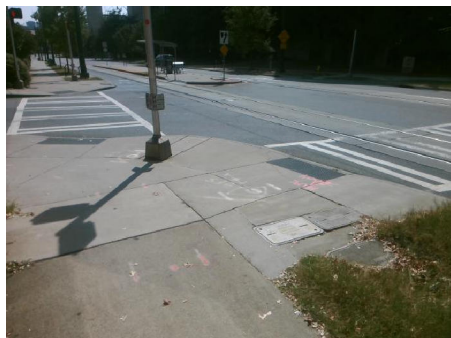
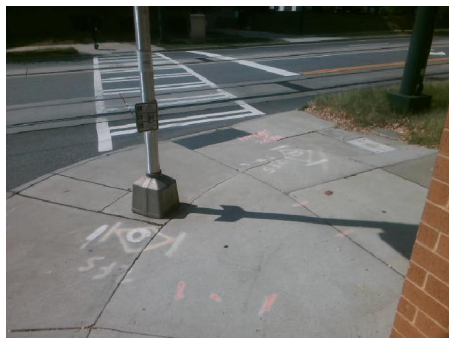
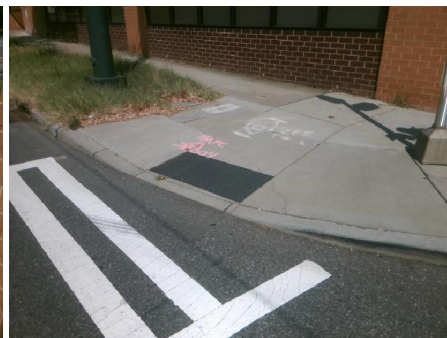
Not Found, R304.5.3, R305.2

Compliance	Description	Data	Compliance	Description	Data
N/A	Ramp Length (in)	70.0	Yes	Ramp Slope (%)	5.9
Yes	Ramp Width (in)	48.0	No	Ramp XSlope (%)	4.0
N/A	Flare Type LT	Sloped	N/A	Flare Type RT	N/A
N/A	Flare Slope LT (%)	10.5	Yes	Flare Slope RT (%)	6.2
N/A	Flare Traversable LT?	No	N/A	Flare Traversable RT?	Yes
Yes	Landing Length (in)	73.0	Yes	DWS Provided?	Yes
Yes	Landing Width (in)	52.0	Yes	DWS Contrast?	Yes
Yes	Landing Slope (%)	0.2	Yes	DWS Length (in)	24.0
No	Landing X Slope (%)	5.3	Yes	DWS Full Width?	Yes
N/A	Landing Curb? (Y/N)	No	No	DWS Offset (in)	2.5
N/A	Shared Landing?	No			
Yes	Gutter Ponding?	No	Yes	Gutter Slope (%)	3.2
Yes	Gutter Lip Ht (in)	0.0	No	Gutter X Slope (%)	2.8
N/A	Painted X Walk1?	Yes	N/A	Painted X Walk2?	N/A
	X Walk 1 Direction	To SW		X Walk 2 Direction	N/A
N/A	X Walk 1 Width (in)	112.0	N/A	X Walk 2 Width (in)	N/A
	X Walk 1 Slope (%)	1.3		X Walk 2 Slope (%)	N/A
	X Walk 1 X Slope (%)	2.3		X Walk 2 X Slope (%)	N/A

Yes	Ramp inside XWalk1?	Yes	N/A	Ramp inside XWalk2?	N/A
	Road Slope (%)	N/A	N/A	Clear Space?	Yes
	Road X Slope (%)	N/A	N/A	Clear Space to XWalk (in)	N/A
Yes	Any Obstructions?	No	Yes	Storm Grate/Utility Hazard?	No
	Obstruction Type			Storm Grate/Utility Type	
		N/A			N/A
			Yes	Surface Condition? (G/P)	Good

**Remove & Replace Entire Ramp.
Remove & Replace Gutter.**
