Access Compliance Report

Public Rights-of-Way

(Curb Ramps)

Intersection ID: N/A	Main Street: HATTON_CROSS_DR	Cross Street: DERWENT_CT	Location: NW
ADA ID: ECA9076B8359	Ramp Type: Directional1	Initial Pass/Fail: Fail	Overall Compliance: No
Codes/Mitigation Info/Possible Solution		Field Measurements/Component Compliance	
Severity Score: 1.25

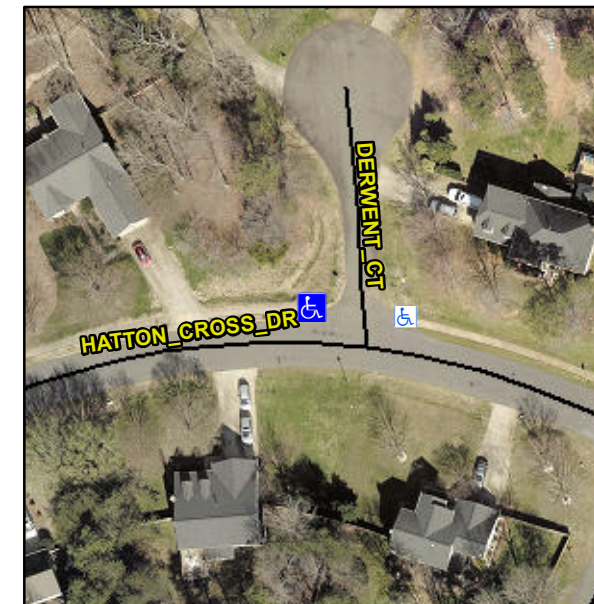
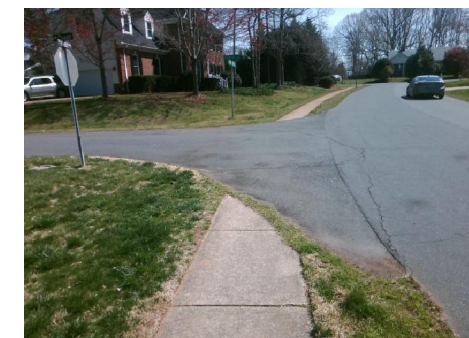
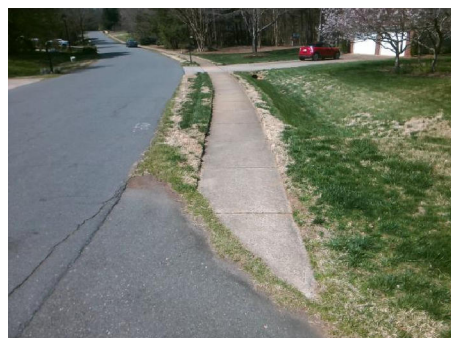
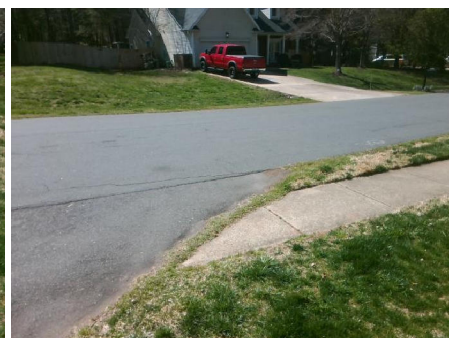
Compliance	Description	Data	Compliance	Description	Data
N/A	Ramp Length (in)	48.0	N/A	Grade Break?	N/A
Yes	Ramp Width (in)	48.0	N/A	Grade Break Slope (%)	0.0
Yes	Ramp Slope (%)	3.9	N/A	Grade Break XSlope (%)	0.0
No	Ramp XSlope (%)	2.3			
N/A	Flare Type LT	N/A	N/A	Flare Type RT	N/A
N/A	Flare Slope LT (%)	N/A	N/A	Flare Slope RT (%)	0.0
N/A	Flare Traversable LT?	N/A	N/A	Flare Traversable RT?	N/A
N/A	Landing Length (in)	0.0	N/A	DWS Provided?	N/A
N/A	Landing Width (in)	0.0	N/A	DWS Contrast?	N/A
N/A	Landing Slope (%)	0.0	N/A	DWS Length (in)	N/A
N/A	Landing X Slope (%)	0.0	N/A	DWS Full Width?	N/A
N/A	Landing Curb? (Y/N)	N/A	N/A	DWS Offset LT (in)	N/A
N/A	Shared Landing?	N/A	N/A	DWS Offset RT (in)	N/A
N/A	Gutter Ponding?	0.0	N/A	Gutter Slope (%)	N/A
N/A	Gutter Lip Ht (in)	0.0	N/A	Gutter X Slope (%)	N/A
N/A	Painted X Walk1?	No		Road Slope (%)	5.2
	X Walk 1 Direction	To E		Road X Slope (%)	1.7
	X Walk 1 Width (in)	N/A		Clear Space?	N/A

X Walk 1 Slope (%)	5.2	N/A	Clear Space to XWalk (in)	N/A
	X Walk 1 X Slope (%)	1.7	N/A	Storm Grate/Utility Hazard?	N/A
N/A	Ramp inside XWalk1?	N/A		Storm Grate/Utility Type	
N/A	Any Obstructions?	N/A			N/A
	Obstruction Type		Yes	Surface Condition? (G/P)	Good
			N/A	Curb Slope (%)	8.2

Remove & Replace Entire Ramp.

R304.5.3

\$ 1600.00
