Access Compliance Report

Public Rights-of-Way

(Curb Ramps)

Intersection ID: 4250	Main Street: RADBOURNE_BV	Cross Street: SYMPHONY_WOODS_DR	Location:	N
ADA ID: ECA9F5C0A193	Ramp Type: Perp	Initial Pass/Fail: Fail	Overall Compliance: No	Severity Score: 13.75
Codes/Mitigation Info/Possible Solution		Field Measurements/Component Compliance

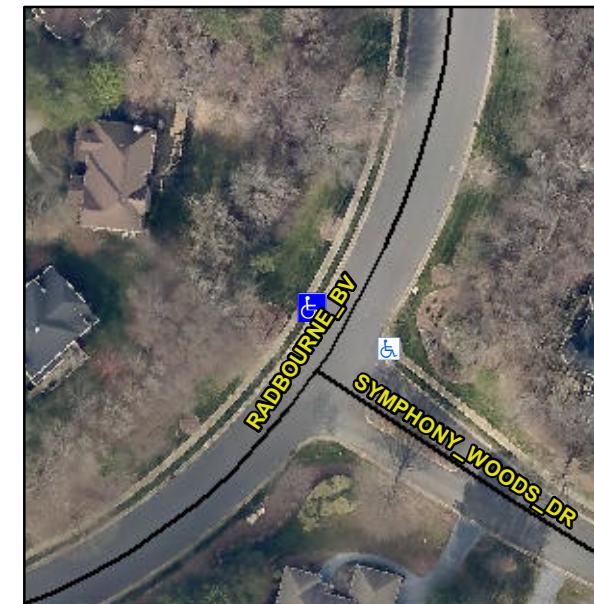
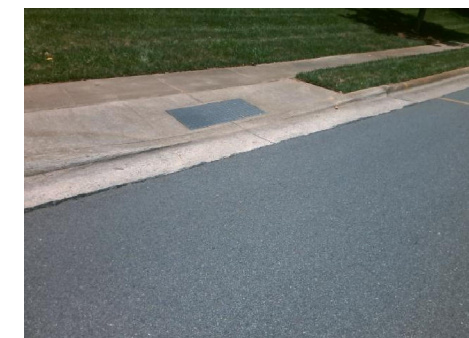
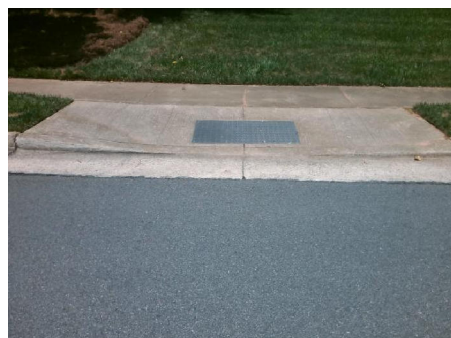
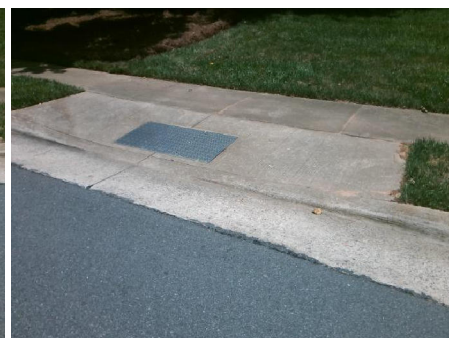
Compliance	Description	Data	Compliance	Description	Data
N/A	Ramp Length (in)	48.0	No	Ramp Slope (%)	11.7
Yes	Ramp Width (in)	48.0	Yes	Ramp XSlope (%)	2.9
N/A	Flare Type LT	N/A	N/A	Flare Type RT	N/A
N/A	Flare Slope LT (%)	N/A	N/A	Flare Slope RT (%)	N/A
N/A	Flare Traversable LT?	N/A	N/A	Flare Traversable RT?	N/A
N/A	Landing Length (in)	N/A	N/A	DWS Provided?	N/A
N/A	Landing Width (in)	N/A	N/A	DWS Contrast?	N/A
N/A	Landing Slope (%)	N/A	N/A	DWS Length (in)	N/A
N/A	Landing X Slope (%)	N/A	N/A	DWS Full Width?	N/A
N/A	Landing Curb? (Y/N)	N/A	N/A	DWS Offset (in)	N/A
N/A	Shared Landing?	N/A			
N/A	Gutter Ponding?	N/A	N/A	Gutter Slope (%)	N/A
N/A	Gutter Lip Ht (in)	N/A	N/A	Gutter X Slope (%)	N/A
N/A	Painted X Walk1?	No	N/A	Painted X Walk2?	N/A
	X Walk 1 Direction	To SE		X Walk 2 Direction	N/A
N/A	X Walk 1 Width (in)	N/A	N/A	X Walk 2 Width (in)	N/A
	X Walk 1 Slope (%)	5.2		X Walk 2 Slope (%)	N/A
	X Walk 1 X Slope (%)	3.6		X Walk 2 X Slope (%)	N/A

N/A	Ramp inside XWalk1?	N/A	N/A	Ramp inside XWalk2?	N/A
	Road Slope (%)	N/A	N/A	Clear Space?	N/A
	Road X Slope (%)	N/A	N/A	Clear Space to XWalk (in)	N/A
N/A	Any Obstructions?	N/A	N/A	Storm Grate/Utility Hazard?	N/A
	Obstruction Type			Storm Grate/Utility Type	
		N/A			N/A
			Yes	Surface Condition? (G/P)	Good

Possible Solutions:

Remove & Replace Entire Ramp.

R304.2.2

\$ 1850.00
