Access Compliance Report

Public Rights-of-Way

(Curb Ramps)

Intersection ID: 6839	Main Street: BELMEADE_DR	Cross Street: BELMEADE_GREEN_DR	Location: W
ADA ID: ECAA93CDFAAC	Ramp Type: Perp	Initial Pass/Fail: Fail	Overall Compliance: No
			Severity Score: 31.25

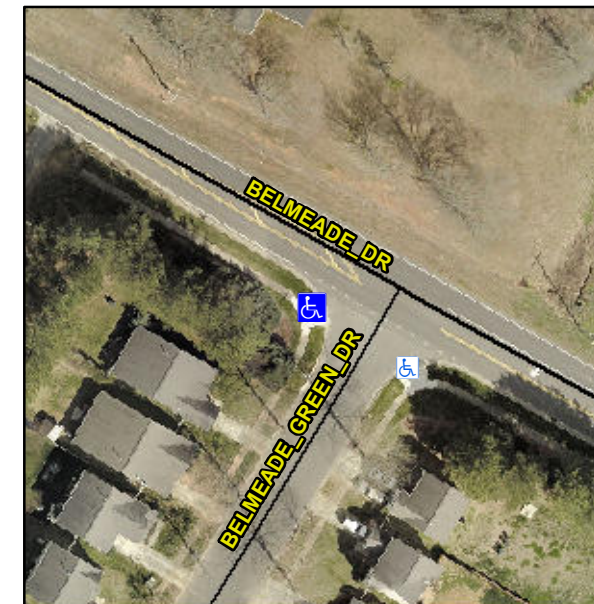
R304.5.1, R304.2.2, R304.5.3

Compliance	Description	Data	Compliance	Description	Data
N/A	Ramp Length (in)	95.0	No	Ramp Slope (%)	9.1
No	Ramp Width (in)	34.5	No	Ramp XSlope (%)	2.6
N/A	Flare Type LT	N/A	N/A	Flare Type RT	N/A
N/A	Flare Slope LT (%)	N/A	N/A	Flare Slope RT (%)	N/A
N/A	Flare Traversable LT?	N/A	N/A	Flare Traversable RT?	N/A
N/A	Landing Length (in)	N/A	N/A	DWS Provided?	N/A
N/A	Landing Width (in)	N/A	N/A	DWS Contrast?	N/A
N/A	Landing Slope (%)	N/A	N/A	DWS Length (in)	N/A
N/A	Landing X Slope (%)	N/A	N/A	DWS Full Width?	N/A
N/A	Landing Curb? (Y/N)	N/A	N/A	DWS Offset (in)	N/A
N/A	Shared Landing?	N/A			
N/A	Gutter Ponding?	N/A	N/A	Gutter Slope (%)	N/A
N/A	Gutter Lip Ht (in)	N/A	N/A	Gutter X Slope (%)	N/A
N/A	Painted X Walk1?	No	N/A	Painted X Walk2?	N/A
	X Walk 1 Direction	To SE		X Walk 2 Direction	N/A
N/A	X Walk 1 Width (in)	N/A	N/A	X Walk 2 Width (in)	N/A
	X Walk 1 Slope (%)	1.4		X Walk 2 Slope (%)	N/A
	X Walk 1 X Slope (%)	3.2		X Walk 2 X Slope (%)	N/A

Remove & Replace Entire Ramp.
