## **Access Compliance Report Public Rights-of-Way** (Curb Ramps)

Intersection ID: 17577 Main Street: HARRIS RD **Cross Street: PROVIDENCE RD** Location: NW ADA ID: ECB01F7C028C Ramp Type: PerpDiag Initial Pass/Fail: Fail **Overall Compliance: No Severity Score:** 37.5

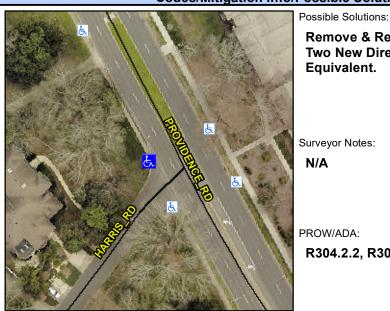
Compl	iance Description	Data	Compl	iance	Description	Data
N/A	Ramp Length (in)	56.0	No	Ramp	Slope (%)	9.0
Yes	Ramp Width (in)	48.0	No	Ramp	XSlope (%)	7.6
N/A	Flare Type LT	N/A	N/A	Flare	Type RT	N/A
N/A	Flare Slope LT (%)	N/A	N/A	Flare	Slope RT (%)	N/A
N/A	Flare Traversable LT?	N/A	N/A	Flare	Traversable RT?	N/A
N/A	Landing Length (in)	N/A	N/A	DWS	Provided?	N/A
N/A	Landing Width (in)	N/A	N/A	DWS	Contrast?	N/A
N/A	Landing Slope (%)	N/A	N/A	DWS	Length (in)	N/A
N/A	Landing X Slope (%)	N/A	N/A	DWS	Full Width?	N/A
N/A	Landing Curb? (Y/N)	N/A	N/A	DWS	Offset (in)	N/A
N/A	Shared Landing?	N/A				
N/A	Gutter Ponding?	N/A	N/A	Gutte	r Slope (%)	N/A
N/A	Gutter Lip Ht (in)	N/A	N/A	Gutte	r X Slope (%)	N/A
N/A	Painted X Walk1?	No	N/A	Paint	ed X Walk2?	No
	X Walk 1 Direction	To SE		X Wa	lk 2 Direction	To NE
N/A	X Walk 1 Width (in)	N/A	N/A	X Wa	lk 2 Width (in)	N/A
	X Walk 1 Slope (%)	4.7		X Wa	lk 2 Slope (%)	1.5
	X Walk 1 X Slope (%)	4.7		X Wa	lk 2 X Slope (%)	5.3

N/A	Ramp inside XWalk1?	N/A	N/A	Ramp	inside XWalk2?	N/A
	Road Slope (%)	8.0	N/A	Clear	Space?	N/A
	Road X Slope (%)	1.8	N/A	Clear	Space to XWalk (in)	N/A
N/A	Any Obstructions?	N/A	N/A	Storm	n Grate/Utility Hazard?	N/A
	Obstruction Type			Storm	Grate/Utility Type	
		N/A				N/A
			Yes	Surfa	ce Condition? (G/P)	Good

Remove & Replace Curb Ramp With **Two New Directional Ramps or** Equivalent.

R304.2.2, R304.5.3

3200.00
