Access Compliance Report

Public Rights-of-Way (Curb Ramps)

Intersection ID: 10587	Main Street: CHARLES_AV	Cross Street: N_MCDOWELL_ST	Location: NE
ADA ID: ECB36CA39140	Ramp Type: Combination2Diag	Initial Pass/Fail: Fail	Overall Compliance: No
		Severity Score: 0

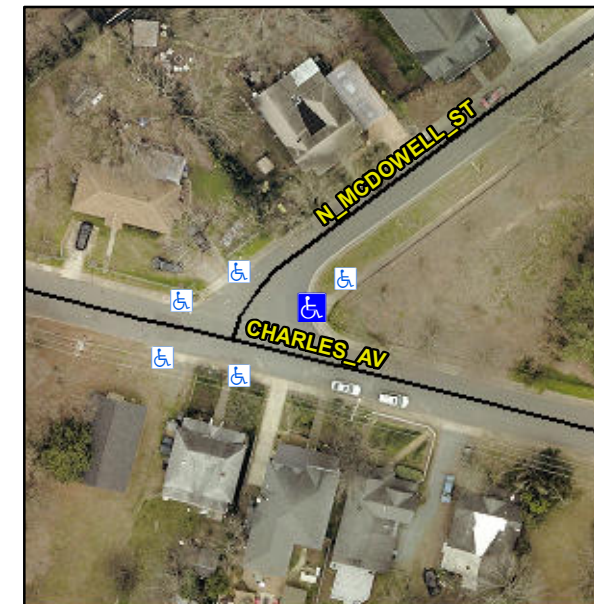
Not Found, R304.5.1, R304.5.3, R304.3.2

Compliance	Description	Data	Compliance	Description	Data
N/A	Ramp Length LT (in)	N/A	N/A	Ramp Length RT (in)	63.0
N/A	Ramp Width LT (in)	N/A	No	Ramp Width RT (in)	32.5
N/A	Ramp Slope LT (%)	N/A	No	Ramp Slope RT (%)	17.1
N/A	Ramp XSlope LT (%)	N/A	Yes	Ramp XSlope RT (%)	1.6
N/A	Ramp Length (in)	24.0	Yes	Ramp Slope (%)	5.9
Yes	Ramp Width (in)	48.0	No	Ramp XSlope (%)	8.9
N/A	Flare Type LT	N/A	N/A	Flare Type RT	N/A
N/A	Flare Slope LT (%)	N/A	N/A	Flare Slope RT (%)	N/A
N/A	Flare Traversable LT?	N/A	N/A	Flare Traversable RT?	N/A
N/A	Landing Length (in)	N/A	N/A	DWS Provided?	N/A
N/A	Landing Width (in)	N/A	N/A	DWS Contrast?	N/A
N/A	Landing Slope (%)	N/A	N/A	DWS Length (in)	N/A
N/A	Landing X Slope (%)	N/A	N/A	DWS Full Width?	N/A
N/A	Landing Curb? (Y/N)	N/A	N/A	DWS Offset (in)	N/A
N/A	Shared Landing?	N/A			
N/A	Gutter Ponding?	N/A	N/A	Gutter Slope (%)	N/A
N/A	Gutter Lip Ht (in)	N/A	N/A	Gutter X Slope (%)	N/A
N/A	Painted X Walk1?	No	N/A	Painted X Walk2?	No

X Walk 1 Direction	To NW		X Walk 2 Direction	To SW
	X Walk 1 Width (in)	N/A		X Walk 2 Width (in)	N/A
	X Walk 1 Slope (%)	3.6		X Walk 2 Slope (%)	3.1
	X Walk 1 X Slope (%)	4.8		X Walk 2 X Slope (%)	7.6
N/A	Ramp inside XWalk1?	N/A	N/A	Ramp inside XWalk2?	N/A
	Road Slope (%)	8.6		Clear Space?	N/A
	Road X Slope (%)	2.5	N/A	Clear Space to XWalk (in)	N/A
			N/A	Any Obstruction?	N/A
				Obstruction Type	N/A
			N/A	Storm Grate/Utility Hazard?	N/A
				Storm Grate/Utility Type	N/A
			Yes	Surface Condition? (G/P)	Good
				Curb Slope (%)	17.1

Remove & Replace Curb Ramp With Two New Directional Ramps or Equivalent.
