# Access Compliance Report

## Public Rights-of-Way

### (Curb Ramps)

| Intersection ID: 29760 | Main Street: CREEK_POINTE_DR | Cross Street: FAWN_HILL_RD | Location: NW |

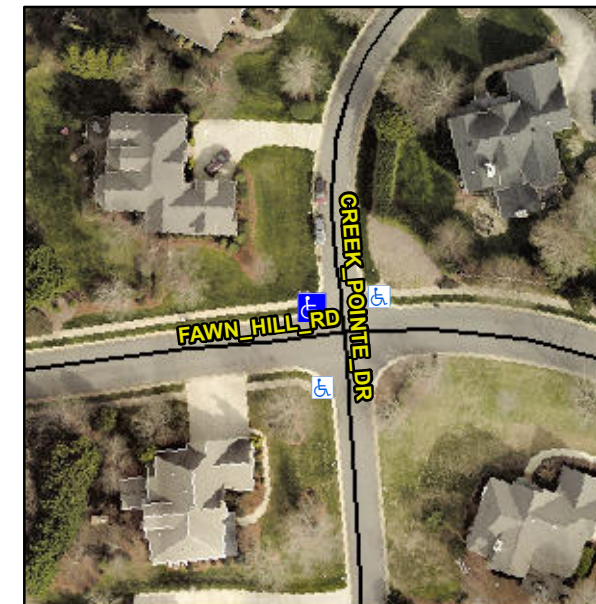
| ADA ID: ECB996B27E8E | Ramp Type: PerpDiag | Initial Pass/Fail: Fail | Overall Compliance: No |
| Severity Score: 10 | | | |

**Not Found, R304.5.1, R304.5.3**

| Compliance | Description | Data | Compliance | Description | Data |
|---|---|---|---|---|---|
| N/A | Ramp Length (in) | 39.5 | Yes | Ramp Slope (%) | 6.2 |
| No | Ramp Width (in) | 40.0 | No | Ramp XSlope (%) | 4.3 |

**Remove & Replace Curb Ramp With Two New Directional Ramps or Equivalent.**

Total Cost: \$ 3200.00
