Access Compliance Report

Public Rights-of-Way

(Curb Ramps)

Intersection ID: 16859	Main Street: ASHMORE_DR	Cross Street: MONROE_RD	Location: S
ADA ID: ECBFB8CC8BDD	Ramp Type: BlendTrans2	Initial Pass/Fail: Fail	Overall Compliance: No
Severity Score: 18.75			
Codes/Mitigation Info/Possible Solution		Field Measurements/Component Compliance

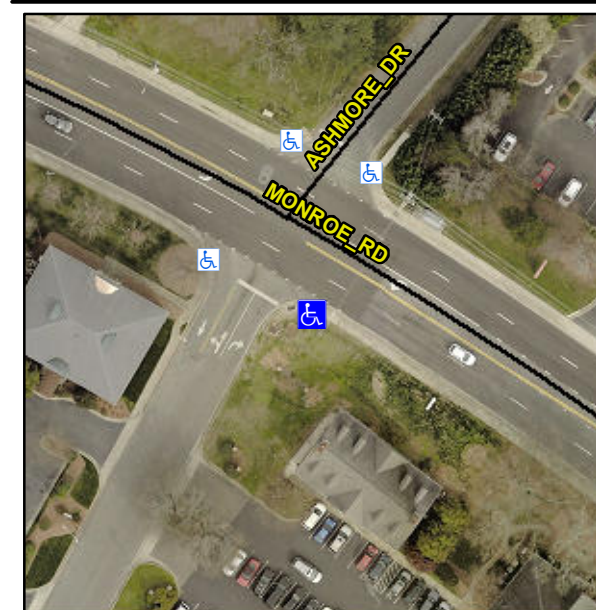
Not Found, R304.5.1, R304.5.3

Compliance	Description	Data	Compliance	Description	Data
N/A	Ramp Length (in)	59.0	Yes	BlendTrans Slope (%)	4.1
No	Ramp Width (in)	35.0	No	BlendTrans XSlope (%)	2.2
N/A	Flare Type LT	N/A	N/A	Flare Type RT	N/A
N/A	Flare Slope LT (%)	N/A	N/A	Flare Slope RT (%)	N/A
N/A	Flare Traversable LT?	N/A	N/A	Flare Traversable RT?	N/A
N/A	Landing Length (in)	N/A	N/A	DWS Provided?	N/A
N/A	Landing Width (in)	N/A	N/A	DWS Contrast?	N/A
N/A	Landing Slope (%)	N/A	N/A	DWS Length (in)	N/A
N/A	Landing X Slope (%)	N/A	N/A	DWS Full Width?	N/A
N/A	Landing Curb? (Y/N)	N/A	N/A	DWS Offset (in)	N/A
N/A	Shared Landing?	N/A			
N/A	Gutter Ponding?	N/A	N/A	Gutter Slope (%)	N/A
N/A	Gutter Lip Ht (in)	N/A	N/A	Gutter X Slope (%)	N/A
N/A	Painted X Walk1?	No	N/A	Painted X Walk2?	No
	X Walk 1 Direction	To NE		X Walk 2 Direction	To NW
	X Walk 1 Width (in)	N/A		X Walk 2 Width (in)	N/A
	X Walk 1 Slope (%)	2.1		X Walk 2 Slope (%)	0.4
	X Walk 1 X Slope (%)	0.6		X Walk 2 X Slope (%)	2.1

N/A	Ramp inside XWalk1?	N/A	N/A	Ramp inside XWalk2?	N/A
	Road Slope (%)	1.4		Clear Space?	N/A
	Road X Slope (%)	1.5	N/A	Clear Space to XWalk (in)	N/A
N/A	Any Obstructions?	N/A	N/A	Storm Grate/Utility Hazard?	N/A
	Obstruction Type			Storm Grate/Utility Type	
		N/A			N/A
			Yes	Surface Condition? (G/P)	Good
			No	Curb Slope (%)	9.4

Possible Solutions:

Remove & Replace Curb Ramp With Two New Directional Ramps or Equivalent.

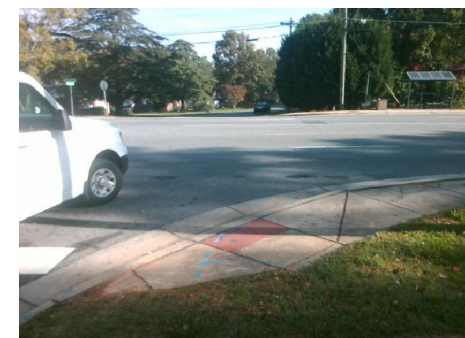
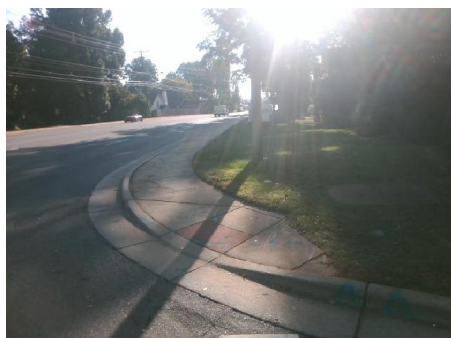
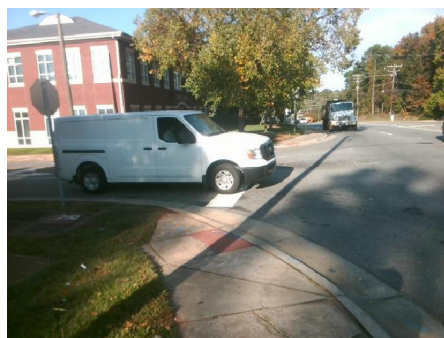
Street 1 Name **MONROE RD**
 Stop Condition-Street 1 **None**
 Street 2 Name **N/A**
 Stop Condition-Street 2 **StopSign**
