# Access Compliance Report

## Public Rights-of-Way

### (Curb Ramps)

Intersection ID: 10036434	Main Street: ROXBOROUGH_RD	Cross Street: N/A	Location: SW
ADA ID: ECC1AF89791C	Ramp Type: PerpDiag	Initial Pass/Fail: Fail	Overall Compliance: No
Severity Score: 12.5			
Codes/Mitigation Info/Possible Solution		Field Measurements/Component Compliance

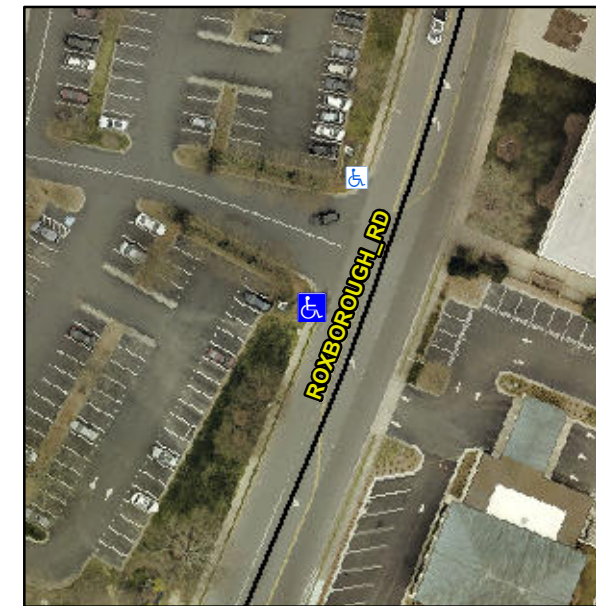
**Not Found, R304.2.2**

Compliance	Description	Data	Compliance	Description	Data
N/A	Ramp Length (in)	47.0	No	Ramp Slope (%)	11.7
Yes	Ramp Width (in)	48.0	Yes	Ramp XSlope (%)	1.3
N/A	Flare Type LT	N/A	N/A	Flare Type RT	N/A
N/A	Flare Slope LT (%)	N/A	N/A	Flare Slope RT (%)	N/A
N/A	Flare Traversable LT?	N/A	N/A	Flare Traversable RT?	N/A
N/A	Landing Length (in)	N/A	N/A	DWS Provided?	N/A
N/A	Landing Width (in)	N/A	N/A	DWS Contrast?	N/A
N/A	Landing Slope (%)	N/A	N/A	DWS Length (in)	N/A
N/A	Landing X Slope (%)	N/A	N/A	DWS Full Width?	N/A
N/A	Landing Curb? (Y/N)	N/A	N/A	DWS Offset (in)	N/A
N/A	Shared Landing?	N/A			
N/A	Gutter Ponding?	N/A	N/A	Gutter Slope (%)	N/A
N/A	Gutter Lip Ht (in)	N/A	N/A	Gutter X Slope (%)	N/A
N/A	Painted X Walk1?	No	N/A	Painted X Walk2?	No
	X Walk 1 Direction	To E		X Walk 2 Direction	To N
N/A	X Walk 1 Width (in)	N/A	N/A	X Walk 2 Width (in)	N/A
	X Walk 1 Slope (%)	6.7		X Walk 2 Slope (%)	0.2
	X Walk 1 X Slope (%)	0.7		X Walk 2 X Slope (%)	0.7

N/A	Ramp inside XWalk1?	N/A	N/A	Ramp inside XWalk2?	N/A
	Road Slope (%)	1.6	N/A	Clear Space?	N/A
	Road X Slope (%)	3.9	N/A	Clear Space to XWalk (in)	N/A
N/A	Any Obstructions?	N/A	N/A	Storm Grate/Utility Hazard?	N/A
	Obstruction Type			Storm Grate/Utility Type	
		N/A			N/A
		Yes		Surface Condition? (G/P)	Good

Possible Solutions:

**Remove & Replace Curb Ramp With Two New Directional Ramps or Equivalent.**

Total Cost: \$ 3200.00
