Access Compliance Report

Public Rights-of-Way

(Curb Ramps)

Intersection ID: 45985	Main Street: MASON_MILL_PL	Cross Street: WILLOW_VALLEY_CT	Location: SE
ADA ID: ECC5AEA17343	Ramp Type: PerpDiag	Initial Pass/Fail: Fail	Overall Compliance: No
Severity Score: 22.5			
Codes/Mitigation Info/Possible Solution		Field Measurements/Component Compliance

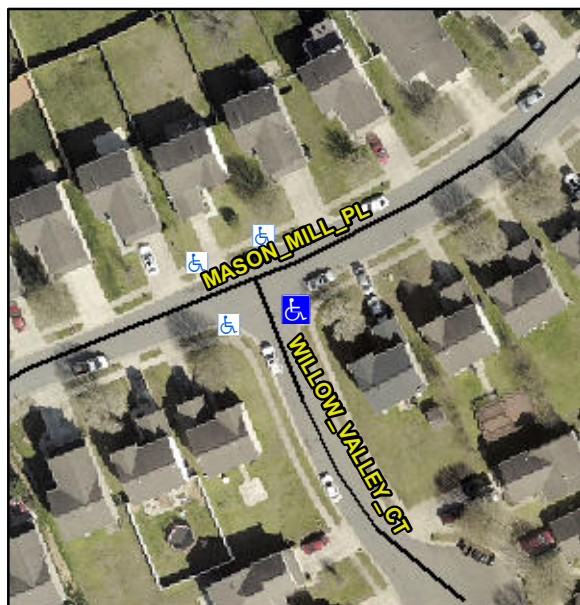
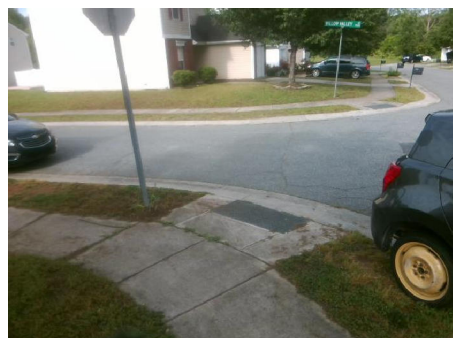
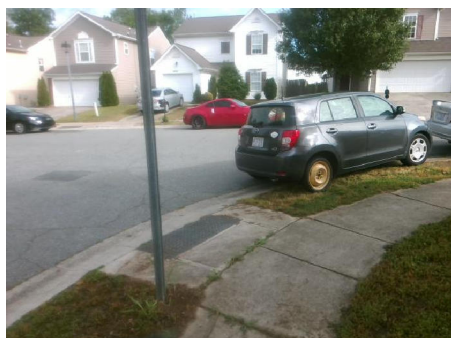
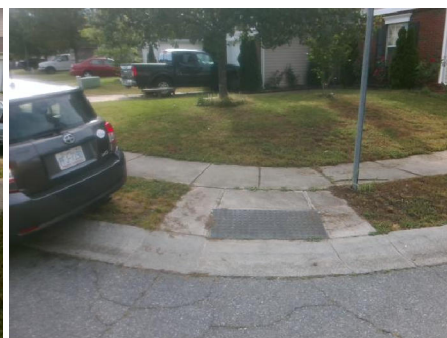
Compliance	Description	Data	Compliance	Description	Data
N/A	Ramp Length (in)	48.0	No	Ramp Slope (%)	10.8
No	Ramp Width (in)	41.0	No	Ramp XSlope (%)	4.6
N/A	Flare Type LT	N/A	N/A	Flare Type RT	N/A
N/A	Flare Slope LT (%)	N/A	N/A	Flare Slope RT (%)	N/A
N/A	Flare Traversable LT?	N/A	N/A	Flare Traversable RT?	N/A
N/A	Landing Length (in)	N/A	N/A	DWS Provided?	N/A
N/A	Landing Width (in)	N/A	N/A	DWS Contrast?	N/A
N/A	Landing Slope (%)	N/A	N/A	DWS Length (in)	N/A
N/A	Landing X Slope (%)	N/A	N/A	DWS Full Width?	N/A
N/A	Landing Curb? (Y/N)	N/A	N/A	DWS Offset (in)	N/A
N/A	Shared Landing?	N/A			
N/A	Gutter Ponding?	N/A	N/A	Gutter Slope (%)	N/A
N/A	Gutter Lip Ht (in)	N/A	N/A	Gutter X Slope (%)	N/A
N/A	Painted X Walk1?	No	N/A	Painted X Walk2?	No
	X Walk 1 Direction	To N		X Walk 2 Direction	To W
N/A	X Walk 1 Width (in)	N/A	N/A	X Walk 2 Width (in)	N/A
	X Walk 1 Slope (%)	2.4		X Walk 2 Slope (%)	0.8
	X Walk 1 X Slope (%)	2.7		X Walk 2 X Slope (%)	1.9

N/A	Ramp inside XWalk1?	N/A	N/A	Ramp inside XWalk2?	N/A
	Road Slope (%)	2.1	N/A	Clear Space?	N/A
	Road X Slope (%)	1.5	N/A	Clear Space to XWalk (in)	N/A
N/A	Any Obstructions?	N/A	N/A	Storm Grate/Utility Hazard?	N/A
	Obstruction Type			Storm Grate/Utility Type	
		N/A			N/A
			Yes	Surface Condition? (G/P)	Good

Remove & Replace Curb Ramp With Two New Directional Ramps or Equivalent.

R304.5.1, R304.2.2, R304.5.3
