Access Compliance Report

Public Rights-of-Way

(Curb Ramps)

Intersection ID: 10077	Main Street: E_35TH_ST	Cross Street: N_DAVIDSON_ST	Location: N
ADA ID: ECD112C1C926	Ramp Type: PerpDiag	Initial Pass/Fail: Fail	Overall Compliance: No
			Severity Score: 13.75

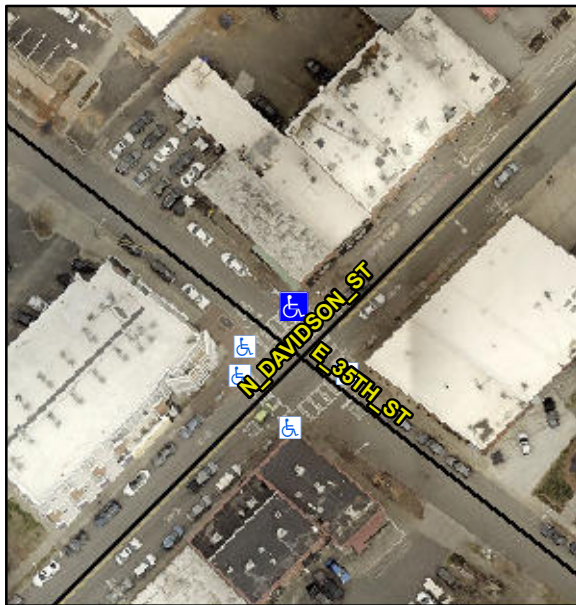
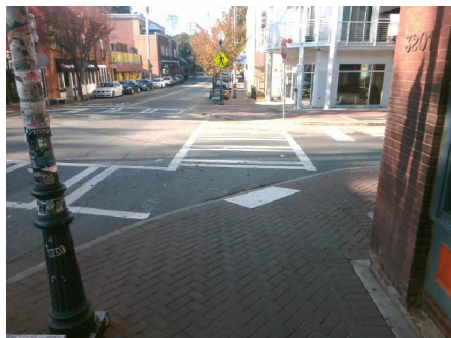
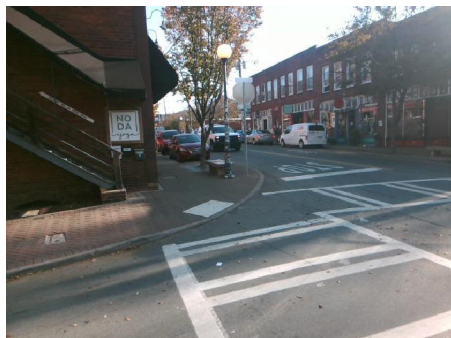
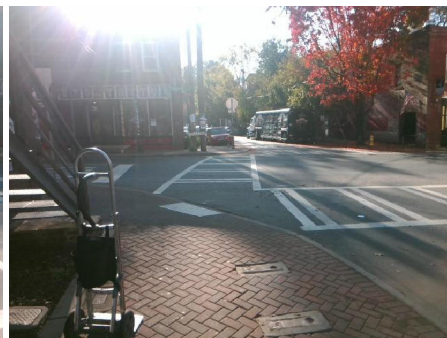
R304.2.2, R304.5.3

Compliance	Description	Data	Compliance	Description	Data
N/A	Ramp Length (in)	76.0	No	Ramp Slope (%)	9.7
Yes	Ramp Width (in)	48.0	No	Ramp XSlope (%)	2.1
N/A	Flare Type LT	N/A	N/A	Flare Type RT	N/A
N/A	Flare Slope LT (%)	N/A	N/A	Flare Slope RT (%)	N/A
N/A	Flare Traversable LT?	N/A	N/A	Flare Traversable RT?	N/A
N/A	Landing Length (in)	N/A	N/A	DWS Provided?	N/A
N/A	Landing Width (in)	N/A	N/A	DWS Contrast?	N/A
N/A	Landing Slope (%)	N/A	N/A	DWS Length (in)	N/A
N/A	Landing X Slope (%)	N/A	N/A	DWS Full Width?	N/A
N/A	Landing Curb? (Y/N)	N/A	N/A	DWS Offset (in)	N/A
N/A	Shared Landing?	N/A			
N/A	Gutter Ponding?	N/A	N/A	Gutter Slope (%)	N/A
N/A	Gutter Lip Ht (in)	1.0	N/A	Gutter X Slope (%)	N/A
N/A	Painted X Walk1?	Yes	N/A	Painted X Walk2?	Yes
	X Walk 1 Direction	To SW		X Walk 2 Direction	To SE
N/A	X Walk 1 Width (in)	110.0	N/A	X Walk 2 Width (in)	89.0
	X Walk 1 Slope (%)	1.2		X Walk 2 Slope (%)	3.7
	X Walk 1 X Slope (%)	3.8		X Walk 2 X Slope (%)	1.5

N/A	Ramp inside XWalk1?	Yes	N/A	Ramp inside XWalk2?	Yes
	Road Slope (%)	4.3	N/A	Clear Space?	N/A
	Road X Slope (%)	0.7	N/A	Clear Space to XWalk (in)	N/A
N/A	Any Obstructions?	N/A	N/A	Storm Grate/Utility Hazard?	N/A
	Obstruction Type			Storm Grate/Utility Type	
		N/A			N/A
		Yes		Surface Condition? (G/P)	Good

Remove & Replace Curb Ramp With Two New Directional Ramps or Equivalent.
