# Access Compliance Report

## Public Rights-of-Way

### (Curb Ramps)

Intersection ID: 46033	Main Street: DOMINION_VILLAGE_DR	Cross Street: SUMMER_VALLEY_CT	Location: NE
ADA ID: ECDB942E98B3	Ramp Type: PerpDiag	Initial Pass/Fail: Fail	Overall Compliance: No
Severity Score: 10			
Codes/Mitigation Info/Possible Solution		Field Measurements/Component Compliance

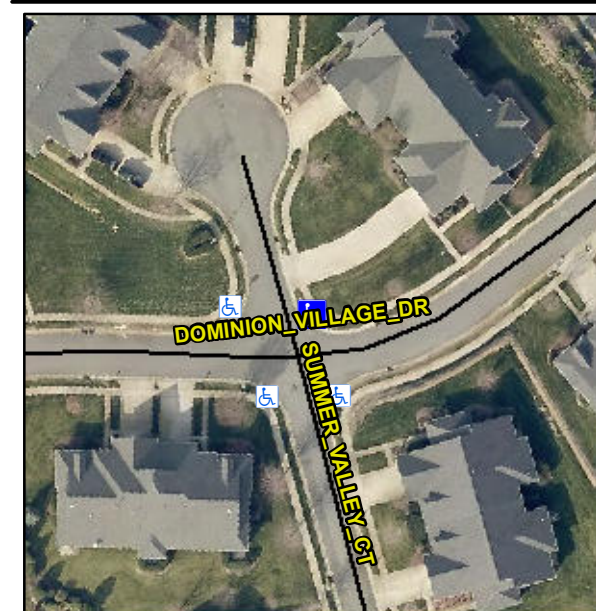
**Not Found, R304.5.1, R304.5.3**

Compliance	Description	Data	Compliance	Description	Data
N/A	Ramp Length (in)	48.0	Yes	Ramp Slope (%)	5.4
No	Ramp Width (in)	41.0	No	Ramp XSlope (%)	2.1
N/A	Flare Type LT	N/A	N/A	Flare Type RT	N/A
N/A	Flare Slope LT (%)	N/A	N/A	Flare Slope RT (%)	N/A
N/A	Flare Traversable LT?	N/A	N/A	Flare Traversable RT?	N/A
N/A	Landing Length (in)	N/A	N/A	DWS Provided?	N/A
N/A	Landing Width (in)	N/A	N/A	DWS Contrast?	N/A
N/A	Landing Slope (%)	N/A	N/A	DWS Length (in)	N/A
N/A	Landing X Slope (%)	N/A	N/A	DWS Full Width?	N/A
N/A	Landing Curb? (Y/N)	N/A	N/A	DWS Offset (in)	N/A
N/A	Shared Landing?	N/A			
N/A	Gutter Ponding?	N/A	N/A	Gutter Slope (%)	N/A
N/A	Gutter Lip Ht (in)	N/A	N/A	Gutter X Slope (%)	N/A
N/A	Painted X Walk1?	No	N/A	Painted X Walk2?	No
	X Walk 1 Direction	To W		X Walk 2 Direction	To S
N/A	X Walk 1 Width (in)	N/A	N/A	X Walk 2 Width (in)	N/A
	X Walk 1 Slope (%)	1.5		X Walk 2 Slope (%)	3.2
	X Walk 1 X Slope (%)	2.1		X Walk 2 X Slope (%)	0.8

N/A	Ramp inside XWalk1?	N/A	N/A	Ramp inside XWalk2?	N/A
	Road Slope (%)	2.0	N/A	Clear Space?	N/A
	Road X Slope (%)	0.5	N/A	Clear Space to XWalk (in)	N/A
N/A	Any Obstructions?	N/A	N/A	Storm Grate/Utility Hazard?	N/A
	Obstruction Type			Storm Grate/Utility Type	
		N/A			N/A
		Yes		Surface Condition? (G/P)	Good

**Remove & Replace Curb Ramp With Two New Directional Ramps or Equivalent.**
