# Access Compliance Report

## Public Rights-of-Way

Intersection ID: 10039889	Main Street: TRADE_PARK_CT	Cross Street: N/A	Location: NW
ADA ID: ECE285082EA3	Ramp Type: PerpDiag	Initial Pass/Fail: Fail	Overall Compliance: No
			Severity Score: 26.25

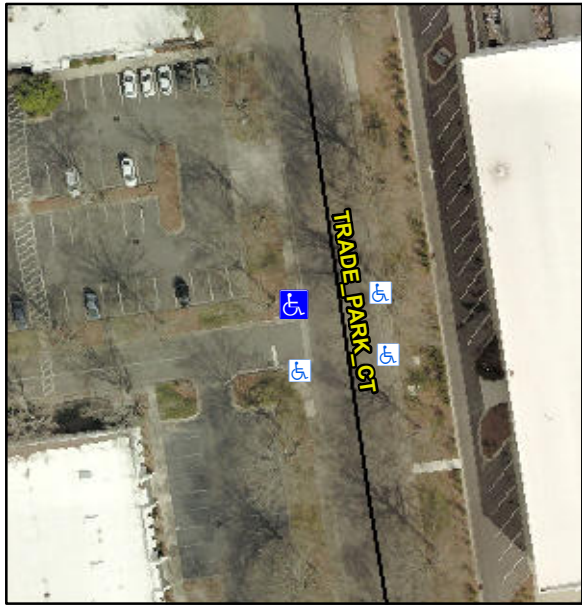
Possible Solutions:		Compliance	Description	Data	Compliance	Description	Data
	<b>Remove &amp; Replace Curb Ramp With Two New Directional Ramps or Equivalent.</b>		N/A	Ramp Length (in)	60.0	No	Ramp Slope (%)	12.9
			Yes	Ramp Width (in)	48.0	No	Ramp XSlope (%)	3.4
			N/A	Flare Type LT	N/A	N/A	Flare Type RT	N/A
			N/A	Flare Slope LT (%)	N/A	N/A	Flare Slope RT (%)	N/A
			N/A	Flare Traversable LT?	N/A	N/A	Flare Traversable RT?	N/A
			N/A	Landing Length (in)	N/A	N/A	DWS Provided?	N/A
			N/A	Landing Width (in)	N/A	N/A	DWS Contrast?	N/A
			N/A	Landing Slope (%)	N/A	N/A	DWS Length (in)	N/A
			N/A	Landing X Slope (%)	N/A	N/A	DWS Full Width?	N/A
Surveyor Notes:		N/A	N/A	Landing Curb? (Y/N)	N/A	N/A	DWS Offset (in)	N/A
			N/A	Shared Landing?	N/A			
PROW/ADA:			N/A	Gutter Ponding?	N/A	N/A	Gutter Slope (%)	N/A
<b>Not Found, R304.2.2, R304.5.3</b>			N/A	Gutter Lip Ht (in)	N/A	N/A	Gutter X Slope (%)	N/A

N/A	Painted X Walk1?	No	N/A	Painted X Walk2?	No
				X Walk 1 Direction	To S		X Walk 2 Direction	To E
			N/A	X Walk 1 Width (in)	N/A	N/A	X Walk 2 Width (in)	N/A
				X Walk 1 Slope (%)	3.5		X Walk 2 Slope (%)	3.2
				X Walk 1 X Slope (%)	3.6		X Walk 2 X Slope (%)	0.0
			N/A	Ramp inside XWalk1?	N/A	N/A	Ramp inside XWalk2?	N/A
				Road Slope (%)	0.1	N/A	Clear Space?	N/A
				Road X Slope (%)	0.9	N/A	Clear Space to XWalk (in)	N/A
			N/A	Any Obstructions?	N/A	N/A	Storm Grate/Utility Hazard?	N/A
				Obstruction Type			Storm Grate/Utility Type	
					N/A			N/A
						Yes	Surface Condition? (G/P)	Good
