Access Compliance Report

Public Rights-of-Way

(Curb Ramps)

Intersection ID: 30275	Main Street: BLYTHEDALE_DR	Cross Street: SMITHTON_LN	Location: E
ADA ID: ECE4AB059752	Ramp Type: PerpDiag	Initial Pass/Fail: Fail	Overall Compliance: No
		Severity Score: 37.5

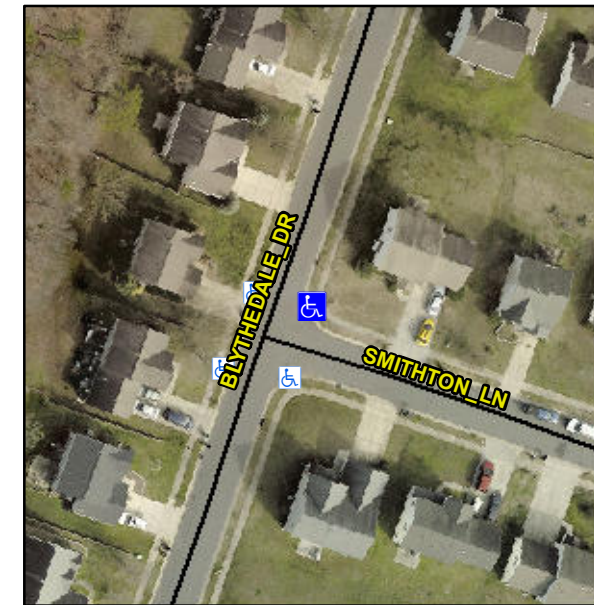
Not Found, R304.2.2, R304.5.3

Compliance	Description	Data	Compliance	Description	Data
N/A	Ramp Length (in)	49.0	No	Ramp Slope (%)	9.7
Yes	Ramp Width (in)	48.0	No	Ramp XSlope (%)	10.9
N/A	Flare Type LT	N/A	N/A	Flare Type RT	N/A
N/A	Flare Slope LT (%)	N/A	N/A	Flare Slope RT (%)	N/A
N/A	Flare Traversable LT?	N/A	N/A	Flare Traversable RT?	N/A
N/A	Landing Length (in)	N/A	N/A	DWS Provided?	N/A
N/A	Landing Width (in)	N/A	N/A	DWS Contrast?	N/A
N/A	Landing Slope (%)	N/A	N/A	DWS Length (in)	N/A
N/A	Landing X Slope (%)	N/A	N/A	DWS Full Width?	N/A
N/A	Landing Curb? (Y/N)	N/A	N/A	DWS Offset (in)	N/A
N/A	Shared Landing?	N/A			
N/A	Gutter Ponding?	N/A	N/A	Gutter Slope (%)	N/A
N/A	Gutter Lip Ht (in)	N/A	N/A	Gutter X Slope (%)	N/A
N/A	Painted X Walk1?	No	N/A	Painted X Walk2?	No
	X Walk 1 Direction	To N		X Walk 2 Direction	To S
N/A	X Walk 1 Width (in)	N/A	N/A	X Walk 2 Width (in)	N/A
	X Walk 1 Slope (%)	3.2		X Walk 2 Slope (%)	4.9
	X Walk 1 X Slope (%)	6.0		X Walk 2 X Slope (%)	5.5

N/A	Ramp inside XWalk1?	N/A	N/A	Ramp inside XWalk2?	N/A
	Road Slope (%)	7.1	N/A	Clear Space?	N/A
	Road X Slope (%)	1.1	N/A	Clear Space to XWalk (in)	N/A
N/A	Any Obstructions?	N/A	N/A	Storm Grate/Utility Hazard?	N/A
	Obstruction Type			Storm Grate/Utility Type	
		N/A			N/A
		Yes		Surface Condition? (G/P)	Good

Possible Solutions:

Remove & Replace Curb Ramp With Two New Directional Ramps or Equivalent.
