Access Compliance Report

Public Rights-of-Way

(Curb Ramps)

Intersection ID: 10861	Main Street: STATESVILLE_AV	Cross Street: DALTON_AV	Location: SE
ADA ID: ECE88FCB1CC1	Ramp Type: PerpDiag	Initial Pass/Fail: Fail	Overall Compliance: No
Severity Score: 21.25			
Codes/Mitigation Info/Possible Solution		Field Measurements/Component Compliance

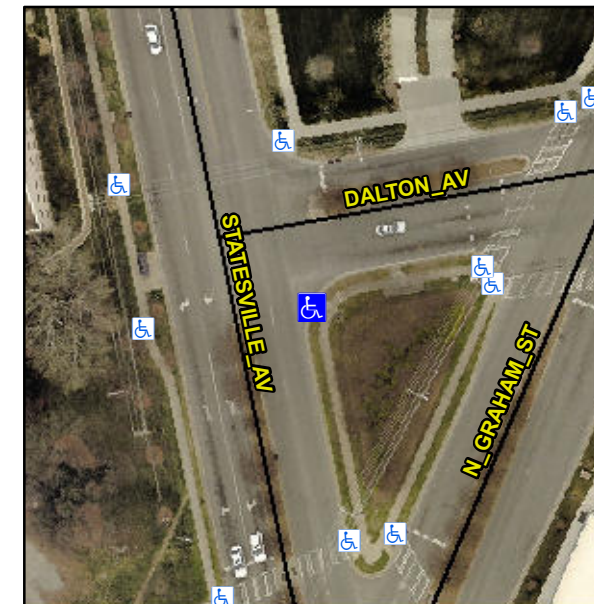
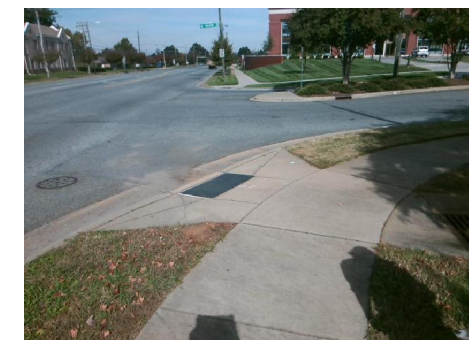
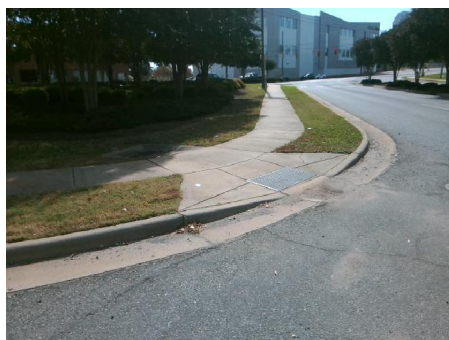
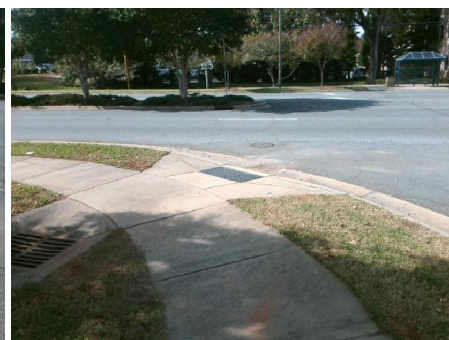
Not Found, R304.5.1, R304.2.2

Compliance	Description	Data	Compliance	Description	Data
N/A	Ramp Length (in)	57.5	No	Ramp Slope (%)	10.1
No	Ramp Width (in)	41.5	Yes	Ramp XSlope (%)	1.0
N/A	Flare Type LT	N/A	N/A	Flare Type RT	N/A
N/A	Flare Slope LT (%)	N/A	N/A	Flare Slope RT (%)	N/A
N/A	Flare Traversable LT?	N/A	N/A	Flare Traversable RT?	N/A
N/A	Landing Length (in)	N/A	N/A	DWS Provided?	N/A
N/A	Landing Width (in)	N/A	N/A	DWS Contrast?	N/A
N/A	Landing Slope (%)	N/A	N/A	DWS Length (in)	N/A
N/A	Landing X Slope (%)	N/A	N/A	DWS Full Width?	N/A
N/A	Landing Curb? (Y/N)	N/A	N/A	DWS Offset (in)	N/A
N/A	Shared Landing?	N/A			
N/A	Gutter Ponding?	N/A	N/A	Gutter Slope (%)	N/A
N/A	Gutter Lip Ht (in)	N/A	N/A	Gutter X Slope (%)	N/A
N/A	Painted X Walk1?	No	N/A	Painted X Walk2?	No
	X Walk 1 Direction	To N		X Walk 2 Direction	To W
N/A	X Walk 1 Width (in)	N/A	N/A	X Walk 2 Width (in)	N/A
	X Walk 1 Slope (%)	3.0		X Walk 2 Slope (%)	0.3
	X Walk 1 X Slope (%)	1.6		X Walk 2 X Slope (%)	1.3

N/A	Ramp inside XWalk1?	N/A	N/A	Ramp inside XWalk2?	N/A
	Road Slope (%)	1.0	N/A	Clear Space?	N/A
	Road X Slope (%)	0.9	N/A	Clear Space to XWalk (in)	N/A
N/A	Any Obstructions?	N/A	N/A	Storm Grate/Utility Hazard?	N/A
	Obstruction Type			Storm Grate/Utility Type	
		N/A			N/A
		Yes		Surface Condition? (G/P)	Good

Remove & Replace Curb Ramp With Two New Directional Ramps or Equivalent.
