# Access Compliance Report

## Public Rights-of-Way

### (Curb Ramps)

Intersection ID: 15491	Main Street: FARM_POND_LN	Cross Street: WOODBEND_DR	Location: NE
ADA ID: ECEF9186B856	Ramp Type: PerpDiag	Initial Pass/Fail: Pass	Overall Compliance: No
		Severity Score: 12.5

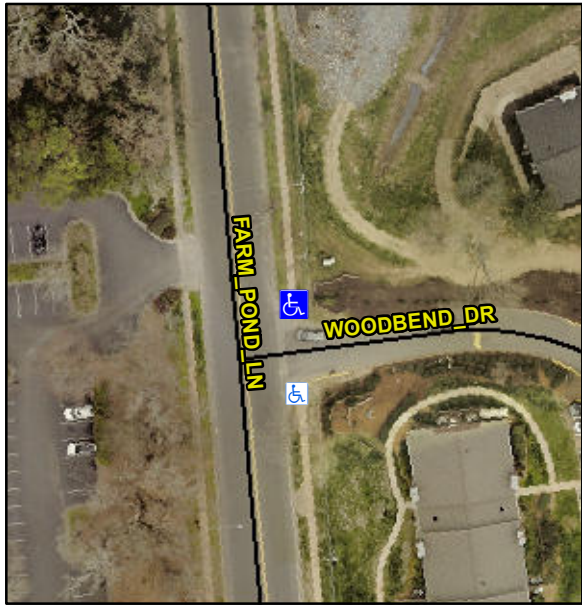
Possible Solutions:		Compliance	Description	Data	Compliance	Description	Data
	Remove & Replace Curb Ramp With Two New Directional Ramps or Equivalent.		N/A	Ramp Length (in)	72.0	Yes	Ramp Slope (%)	7.6
			Yes	Ramp Width (in)	48.0	Yes	Ramp XSlope (%)	0.6
			N/A	Flare Type LT	Sloped	N/A	Flare Type RT	N/A
			N/A	Flare Slope LT (%)	4.6	N/A	Flare Slope RT (%)	4.5
			N/A	Flare Traversable LT?	Yes	N/A	Flare Traversable RT?	No
			No	Landing Length (in)	N/A	Yes	DWS Provided?	Yes
			No	Landing Width (in)	N/A	Yes	DWS Contrast?	Yes
			No	Landing Slope (%)	N/A	Yes	DWS Length (in)	24.0
			No	Landing X Slope (%)	N/A	No	DWS Full Width?	No
			N/A	Landing Curb? (Y/N)	No	No	DWS Offset (in)	3.0
			N/A	Shared Landing?	N/A			
			Yes	Gutter Ponding?	No	Yes	Gutter Slope (%)	1.2
			Yes	Gutter Lip Ht (in)	0.0	Yes	Gutter X Slope (%)	1.0
			N/A	Painted X Walk1?	No	N/A	Painted X Walk2?	No

X Walk 1 Direction	To W		X Walk 2 Direction	To S
			N/A	X Walk 1 Width (in)	N/A	N/A	X Walk 2 Width (in)	N/A
				X Walk 1 Slope (%)	0.5		X Walk 2 Slope (%)	1.4
				X Walk 1 X Slope (%)	0.2		X Walk 2 X Slope (%)	0.5
		N/A	Ramp inside XWalk1?	N/A	N/A	Ramp inside XWalk2?	N/A	
			Road Slope (%)	0.0	N/A	Clear Space?	Yes	
			Road X Slope (%)	1.6	N/A	Clear Space to XWalk (in)	N/A	
		Yes	Any Obstructions?	No	Yes	Storm Grate/Utility Hazard?	No	
			Obstruction Type			Storm Grate/Utility Type		
					N/A		N/A	
					Yes	Surface Condition? (G/P)	Good	
							</
