## **Access Compliance Report Public Rights-of-Way** (Curb Ramps)

Intersection ID: 30001 Main Street: BACKWATER DR Cross Street: CORBETT SQUARE LN Location: NW **Severity Score:** ADA ID: ECF85D6F82BB Ramp Type: BlendTrans2 Initial Pass/Fail: Fail **Overall Compliance: No** 12.5

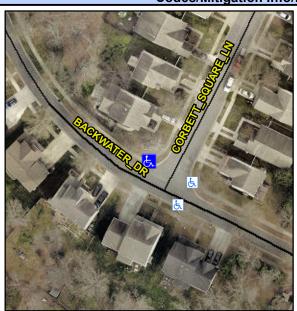
**BACKWATER DR** None **CORBETT SQUARE LN** StopSign N/A Ramp Length (in) 121.0 Yes Ramp Width (in) 48.0 N/A Flare Type LT N/A N/A Flare Slope LT (%) N/A N/A Flare Traversable LT? N/A N/A N/A Landing Length (in) N/A Landing Width (in) N/A N/A N/A Landing Slope (%) N/A Landing X Slope (%) N/A N/A Landing Curb? (Y/N) N/A N/A N/A Shared Landing? N/A **Gutter Ponding?** N/A N/A Gutter Lip Ht (in) N/A N/A Painted X Walk1? No X Walk 1 Direction To S N/A X Walk 1 Width (in) X Walk 1 Slope (%) 2.4 X Walk 1 X Slope (%) 3.7 N/A N/A Ramp inside XWalk1? Road Slope (%) 2.6 Road X Slope (%) 0.4 N/A N/A Any Obstructions?

Street 1 Name Stop Condition-Street 1 Street 2 Name Stop Condition-Street 2 Remove & Replace Curb Ramp With Two New Directional Ramps or Equivalent.
