Access Compliance Report

Public Rights-of-Way

(Curb Ramps)

Intersection ID: 15576	Main Street: LAWYERS_RD	Cross Street: IDLEWILD_RD_NORTH	Location: SE
ADA ID: ECF92372BDEB	Ramp Type: MedianPerp	Initial Pass/Fail: Fail	Overall Compliance: No
Severity Score: 13.75			
Codes/Mitigation Info/Possible Solution		Field Measurements/Component Compliance

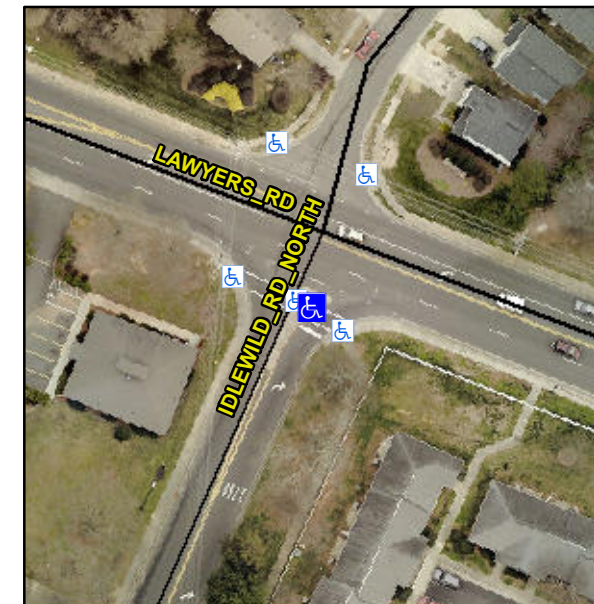
Not Found, R304.2.2, R304.5.3

Compliance	Description	Data	Compliance	Description	Data
N/A	Ramp Length (in)	55.0	No	Ramp Slope (%)	10.6
Yes	Ramp Width (in)	48.0	No	Ramp XSlope (%)	2.7
N/A	Flare Type LT	N/A	N/A	Flare Type RT	N/A
N/A	Flare Slope LT (%)	N/A	N/A	Flare Slope RT (%)	N/A
N/A	Flare Traversable LT?	N/A	N/A	Flare Traversable RT?	N/A
N/A	Landing Length (in)	N/A	N/A	DWS Provided?	N/A
N/A	Landing Width (in)	N/A	N/A	DWS Contrast?	N/A
N/A	Landing Slope (%)	N/A	N/A	DWS Length (in)	N/A
N/A	Landing X Slope (%)	N/A	N/A	DWS Full Width?	N/A
N/A	Landing Curb? (Y/N)	N/A	N/A	DWS Offset (in)	N/A
N/A	Shared Landing?	N/A			
N/A	Gutter Ponding?	N/A	N/A	Gutter Slope (%)	N/A
N/A	Gutter Lip Ht (in)	N/A	N/A	Gutter X Slope (%)	N/A
N/A	Painted X Walk1?	Yes	N/A	Painted X Walk2?	N/A
	X Walk 1 Direction	To SE		X Walk 2 Direction	N/A
N/A	X Walk 1 Width (in)	82.0	N/A	X Walk 2 Width (in)	N/A
	X Walk 1 Slope (%)	0.7		X Walk 2 Slope (%)	N/A
	X Walk 1 X Slope (%)	2.5		X Walk 2 X Slope (%)	N/A

N/A	Ramp inside XWalk1?	Yes	N/A	Ramp inside XWalk2?	N/A
	Road Slope (%)	N/A	N/A	Clear Space?	N/A
	Road X Slope (%)	N/A	N/A	Clear Space to XWalk (in)	N/A
N/A	Any Obstructions?	N/A	N/A	Storm Grate/Utility Hazard?	N/A
	Obstruction Type			Storm Grate/Utility Type	
		N/A			N/A
			Yes	Surface Condition? (G/P)	Good

Possible Solutions:

Remove & Replace Entire Ramp.
