# Access Compliance Report

## Public Rights-of-Way

### (Curb Ramps)

Intersection ID: 30548	Main Street: SOUTH_BV	Cross Street: CAROLINA_PAVILLION_DR_S	Location: NW
ADA ID: ECFB449C72C5	Ramp Type: Perp	Initial Pass/Fail: Fail	Overall Compliance: No
		Severity Score: 12.5

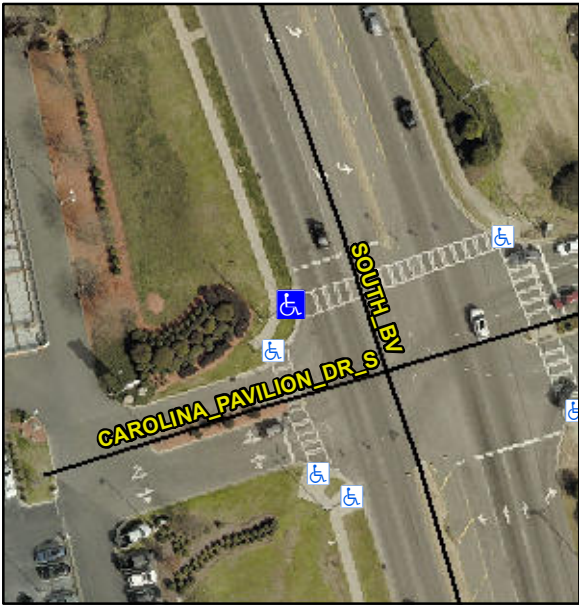
Possible Solutions:		Compliance	Description	Data	Compliance	Description	Data
	Remove & Replace Entire Ramp.		N/A	Ramp Length (in)	77.5	Yes	Ramp Slope (%)	7.2
			Yes	Ramp Width (in)	71.0	No	Ramp XSlope (%)	5.9
			N/A	Flare Type LT	N/A	N/A	Flare Type RT	N/A
			N/A	Flare Slope LT (%)	N/A	N/A	Flare Slope RT (%)	N/A
			N/A	Flare Traversable LT?	N/A	N/A	Flare Traversable RT?	N/A
			N/A	Landing Length (in)	N/A	N/A	DWS Provided?	N/A
			N/A	Landing Width (in)	N/A	N/A	DWS Contrast?	N/A
			N/A	Landing Slope (%)	N/A	N/A	DWS Length (in)	N/A
			N/A	Landing X Slope (%)	N/A	N/A	DWS Full Width?	N/A
Surveyor Notes:	N/A		N/A	Landing Curb? (Y/N)	N/A	N/A	DWS Offset (in)	N/A
			N/A	Shared Landing?	N/A			
	PROW/ADA:		N/A	Gutter Ponding?	N/A	N/A	Gutter Slope (%)	N/A
	Not Found, R304.5.3		N/A	Gutter Lip Ht (in)	N/A	N/A	Gutter X Slope (%)	N/A

N/A	Painted X Walk1?	Yes	N/A	Painted X Walk2?	N/A
				X Walk 1 Direction	To E		X Walk 2 Direction	N/A
			N/A	X Walk 1 Width (in)	134.0	N/A	X Walk 2 Width (in)	N/A
				X Walk 1 Slope (%)	1.3		X Walk 2 Slope (%)	N/A
				X Walk 1 X Slope (%)	2.6		X Walk 2 X Slope (%)	N/A
			N/A	Ramp inside XWalk1?	Yes	N/A	Ramp inside XWalk2?	N/A
				Road Slope (%)	N/A	N/A	Clear Space?	N/A
				Road X Slope (%)	N/A	N/A	Clear Space to XWalk (in)	N/A
			N/A	Any Obstructions?	N/A	N/A	Storm Grate/Utility Hazard?	N/A
				Obstruction Type			Storm Grate/Utility Type	
					N/A			N/A
						Yes	Surface Condition? (G/P)	Good
