# Access Compliance Report

## Public Rights-of-Way

### (Curb Ramps)

Intersection ID: 17601	Main Street: E_INDEPENDENCE_BV	Cross Street: CITY_VIEW_DR	Location: NE
ADA ID: ECFF34E1F841	Ramp Type: PerpDiag	Initial Pass/Fail: Fail	Overall Compliance: No
Severity Score: 37.5			
Codes/Mitigation Info/Possible Solution		Field Measurements/Component Compliance

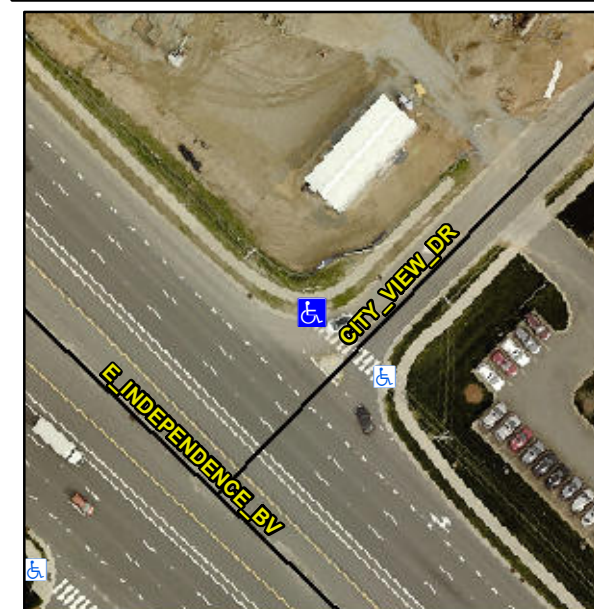
Compliance	Description	Data	Compliance	Description	Data
N/A	Ramp Length (in)	71.0	No	Ramp Slope (%)	10.9
Yes	Ramp Width (in)	58.0	No	Ramp XSlope (%)	9.0
N/A	Flare Type LT	N/A	N/A	Flare Type RT	N/A
N/A	Flare Slope LT (%)	N/A	N/A	Flare Slope RT (%)	N/A
N/A	Flare Traversable LT?	N/A	N/A	Flare Traversable RT?	N/A
N/A	Landing Length (in)	N/A	N/A	DWS Provided?	N/A
N/A	Landing Width (in)	N/A	N/A	DWS Contrast?	N/A
N/A	Landing Slope (%)	N/A	N/A	DWS Length (in)	N/A
N/A	Landing X Slope (%)	N/A	N/A	DWS Full Width?	N/A
N/A	Landing Curb? (Y/N)	N/A	N/A	DWS Offset (in)	N/A
N/A	Shared Landing?	N/A			
N/A	Gutter Ponding?	N/A	N/A	Gutter Slope (%)	N/A
N/A	Gutter Lip Ht (in)	N/A	N/A	Gutter X Slope (%)	N/A
N/A	Painted X Walk1?	No	N/A	Painted X Walk2?	Yes
	X Walk 1 Direction	To SW		X Walk 2 Direction	To SE
N/A	X Walk 1 Width (in)	N/A	N/A	X Walk 2 Width (in)	118.0
	X Walk 1 Slope (%)	9.0		X Walk 2 Slope (%)	2.6
	X Walk 1 X Slope (%)	0.4		X Walk 2 X Slope (%)	7.3

N/A	Ramp inside XWalk1?	N/A	N/A	Ramp inside XWalk2?	Yes
	Road Slope (%)	6.0	N/A	Clear Space?	N/A
	Road X Slope (%)	6.1	N/A	Clear Space to XWalk (in)	N/A
N/A	Any Obstructions?	N/A	N/A	Storm Grate/Utility Hazard?	N/A
	Obstruction Type			Storm Grate/Utility Type	
		N/A			N/A
		Yes		Surface Condition? (G/P)	Good

**Remove & Replace Curb Ramp With Two New Directional Ramps or Equivalent.**

**R304.2.2, R304.5.3**

Total Cost: \$ 3200.00
