# Access Compliance Report

## Public Rights-of-Way

### (Curb Ramps)

Intersection ID: 53339	Main Street: NORTHLAKE CENTRE PY	Cross Street: CALHOUN ST	Location: NW
ADA ID: ED004504EA26	Ramp Type: BlendTrans1	Initial Pass/Fail: Fail	Overall Compliance: No
Codes/Mitigation Info/Possible Solution		Field Measurements/Component Compliance	
Severity Score: 8.75

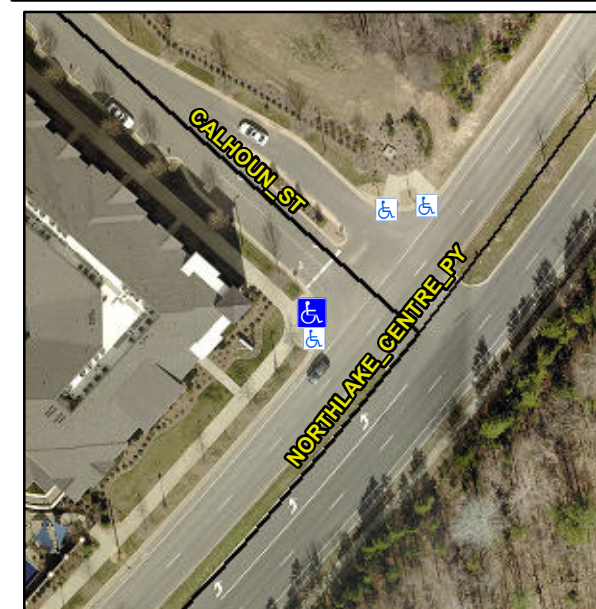
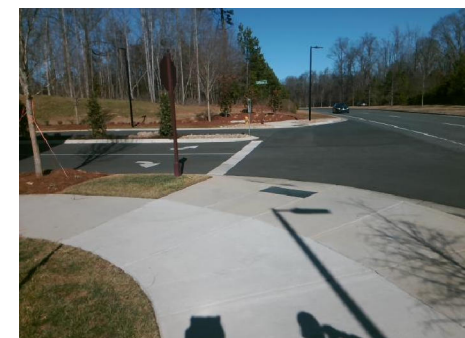
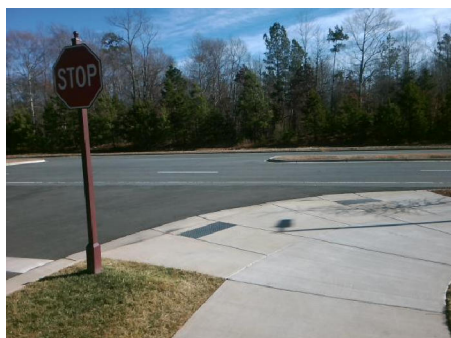
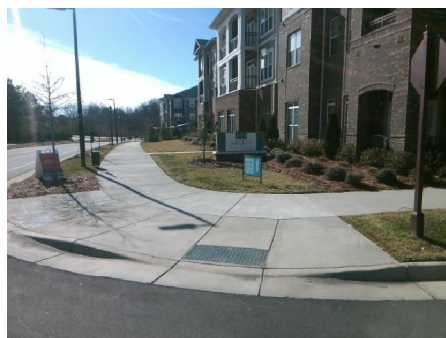
Compliance	Description	Data	Compliance	Description	Data
N/A	Ramp Length (in)	95.0	Yes	BlendTrans Slope (%)	1.9
No	Ramp Width (in)	46.0	Yes	BlendTrans XSlope (%)	0.2
N/A	Flare Type LT	N/A	N/A	Flare Type RT	N/A
N/A	Flare Slope LT (%)	N/A	N/A	Flare Slope RT (%)	N/A
N/A	Flare Traversable LT?	N/A	N/A	Flare Traversable RT?	N/A
N/A	Landing Length (in)	N/A	N/A	DWS Provided?	N/A
N/A	Landing Width (in)	N/A	N/A	DWS Contrast?	N/A
N/A	Landing Slope (%)	N/A	N/A	DWS Length (in)	N/A
N/A	Landing X Slope (%)	N/A	N/A	DWS Full Width?	N/A
N/A	Landing Curb? (Y/N)	N/A	N/A	DWS Offset (in)	N/A
N/A	Shared Landing?	N/A			
N/A	Gutter Ponding?	N/A	N/A	Gutter Slope (%)	N/A
N/A	Gutter Lip Ht (in)	N/A	N/A	Gutter X Slope (%)	N/A
N/A	Painted X Walk1?	No	N/A	Painted X Walk2?	N/A
	X Walk 1 Direction	To NE		X Walk 2 Direction	N/A
	X Walk 1 Width (in)	N/A		X Walk 2 Width (in)	N/A
	X Walk 1 Slope (%)	3.1		X Walk 2 Slope (%)	N/A
	X Walk 1 X Slope (%)	0.2		X Walk 2 X Slope (%)	N/A

N/A	Ramp inside XWalk1?	N/A	N/A	Ramp inside XWalk2?	N/A
	Road Slope (%)	0.2		Clear Space?	N/A
	Road X Slope (%)	3.1	N/A	Clear Space to XWalk (in)	N/A
N/A	Any Obstructions?	N/A	N/A	Storm Grate/Utility Hazard?	N/A
	Obstruction Type			Storm Grate/Utility Type	
		N/A			N/A
			Yes	Surface Condition? (G/P)	Good
			N/A	Curb Slope (%)	0.5

**Remove & Replace Curb Ramp With Two New Directional Ramps or Equivalent.**

**R304.5.1**
