Access Compliance Report

Public Rights-of-Way

| Intersection ID: 12088 | Main Street: MILLERTON_AV | Cross Street: EVERGREEN_DR | Location: W |
| ADA ID: ED046DAD6ACB | Ramp Type: Perp | Initial Pass/Fail: Fail | Overall Compliance: No |

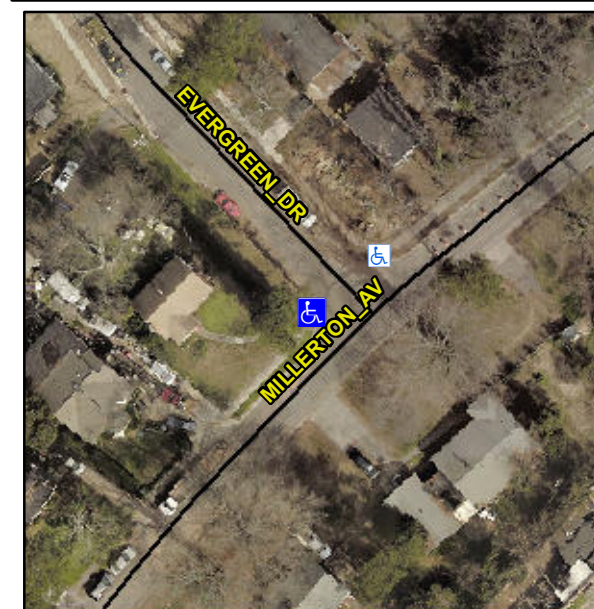
| Severity Score: 33.75 | | | |

Not Found, R304.5.1, R304.5.3

| Compliance | Description | Data | Compliance | Description | Data |
|---|---|---|---|---|---|
| N/A | Ramp Length (in) | 41.0 | Yes | Ramp Slope (%) | 7.0 |
| No | Ramp Width (in) | 47.0 | No | Ramp XSlope (%) | 8.0 |

Possible Solutions:

Remove & Replace Entire Ramp.

Total Cost: \$ 1850.00
