Access Compliance Report

Public Rights-of-Way

(Curb Ramps)

Intersection ID: 17274	Main Street: MONROE_RD	Cross Street: VISTA_DR	Location: NW
ADA ID: ED0DCB982C9D	Ramp Type: Directional1	Initial Pass/Fail: Pass	Overall Compliance: Yes
Severity Score: 0			
Codes/Mitigation Info/Possible Solution		Field Measurements/Component Compliance

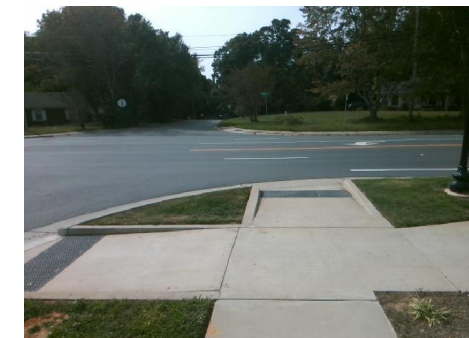
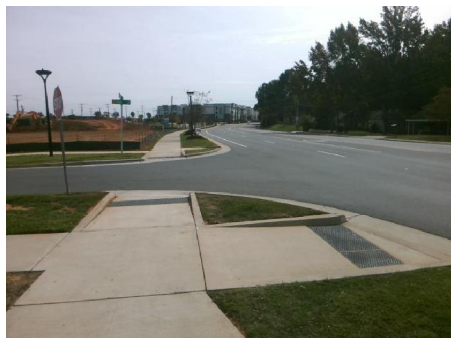
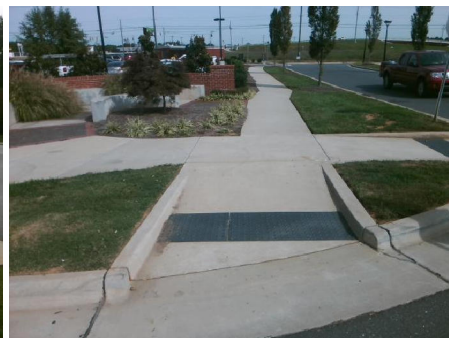
Compliance	Description	Data	Compliance	Description	Data
N/A	Ramp Length (in)	96.0	Yes	Grade Break?	Yes
Yes	Ramp Width (in)	75.0	Yes	Grade Break Slope (%)	2.1
Yes	Ramp Slope (%)	2.1	Yes	Grade Break XSlope (%)	0.3
Yes	Ramp XSlope (%)	1.7			
Yes	Flare Type LT	N/A	Yes	Flare Type RT	N/A
N/A	Flare Slope LT (%)	N/A	N/A	Flare Slope RT (%)	N/A
N/A	Flare Traversable LT?	No	N/A	Flare Traversable RT?	No
Yes	Landing Length (in)	70.0	Yes	DWS Provided?	Yes
Yes	Landing Width (in)	90.0	Yes	DWS Contrast?	Yes
Yes	Landing Slope (%)	0.1	Yes	DWS Length (in)	24.0
Yes	Landing X Slope (%)	0.8	Yes	DWS Full Width?	Yes
N/A	Landing Curb? (Y/N)	No	Yes	DWS Offset LT (in)	21.0
N/A	Shared Landing?	Yes	Yes	DWS Offset RT (in)	0.0
Yes	Gutter Ponding?	No	Yes	Gutter Slope (%)	3.6
Yes	Gutter Lip Ht (in)	0.0	Yes	Gutter X Slope (%)	0.6
N/A	Painted X Walk1?	No		Road Slope (%)	3.5
	X Walk 1 Direction	To SW		Road X Slope (%)	1.3
	X Walk 1 Width (in)	N/A		Clear Space?	Yes

X Walk 1 Slope (%)	3.5	N/A	Clear Space to XWalk (in)	N/A
	X Walk 1 X Slope (%)	1.3	Yes	Storm Grate/Utility Hazard?	No
N/A	Ramp inside XWalk1?	N/A		Storm Grate/Utility Type	
Yes	Any Obstructions?	No			N/A
	Obstruction Type		Yes	Surface Condition? (G/P)	Good
			N/A	Curb Slope (%)	2.2
