Access Compliance Report

Public Rights-of-Way

(Curb Ramps)

Intersection ID: 14038	Main Street: RIDGE_AV	Cross Street: WEST_BV	Location: SW
ADA ID: ED11B2E40AC6	Ramp Type: PerpDiag	Initial Pass/Fail: Fail	Overall Compliance: No
		Severity Score: 8.75

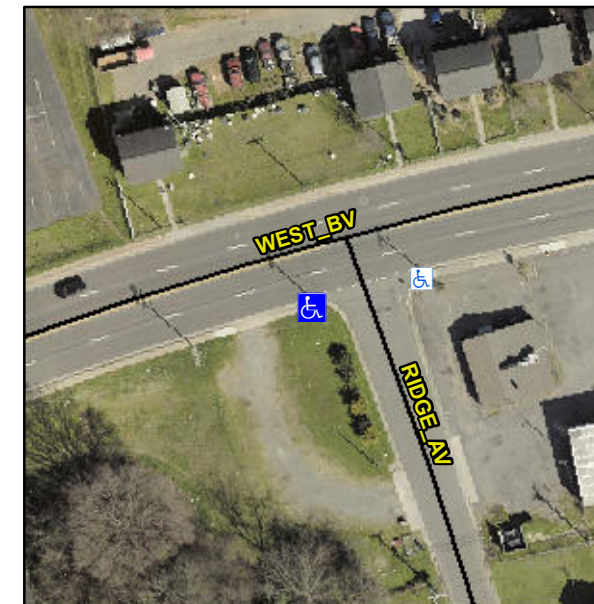
Not Found, R304.5.1

Compliance	Description	Data	Compliance	Description	Data
N/A	Ramp Length (in)	45.0	Yes	Ramp Slope (%)	5.5
No	Ramp Width (in)	38.0	Yes	Ramp XSlope (%)	1.9
N/A	Flare Type LT	N/A	N/A	Flare Type RT	N/A
N/A	Flare Slope LT (%)	N/A	N/A	Flare Slope RT (%)	N/A
N/A	Flare Traversable LT?	N/A	N/A	Flare Traversable RT?	N/A
N/A	Landing Length (in)	N/A	N/A	DWS Provided?	N/A
N/A	Landing Width (in)	N/A	N/A	DWS Contrast?	N/A
N/A	Landing Slope (%)	N/A	N/A	DWS Length (in)	N/A
N/A	Landing X Slope (%)	N/A	N/A	DWS Full Width?	N/A
N/A	Landing Curb? (Y/N)	N/A	N/A	DWS Offset (in)	N/A
N/A	Shared Landing?	N/A			
N/A	Gutter Ponding?	N/A	N/A	Gutter Slope (%)	N/A
N/A	Gutter Lip Ht (in)	N/A	N/A	Gutter X Slope (%)	N/A
N/A	Painted X Walk1?	No	N/A	Painted X Walk2?	No
	X Walk 1 Direction	To E		X Walk 2 Direction	To N
N/A	X Walk 1 Width (in)	N/A	N/A	X Walk 2 Width (in)	N/A
	X Walk 1 Slope (%)	0.1		X Walk 2 Slope (%)	1.0
	X Walk 1 X Slope (%)	1.0		X Walk 2 X Slope (%)	0.7

N/A	Ramp inside XWalk1?	N/A	N/A	Ramp inside XWalk2?	N/A
	Road Slope (%)	0.9	N/A	Clear Space?	N/A
	Road X Slope (%)	1.4	N/A	Clear Space to XWalk (in)	N/A
N/A	Any Obstructions?	N/A	N/A	Storm Grate/Utility Hazard?	N/A
	Obstruction Type			Storm Grate/Utility Type	
		N/A			N/A
		Yes		Surface Condition? (G/P)	Good

Remove & Replace Curb Ramp With Two New Directional Ramps or Equivalent.
