Access Compliance Report

Public Rights-of-Way

(Curb Ramps)

Intersection ID: 48460	Main Street: TARPWAY_RD	Cross Street: PANGLEMONT_DR	Location: NE
ADA ID: ED19A449EEC6	Ramp Type: PerpDiag	Initial Pass/Fail: Fail	Overall Compliance: No
			Severity Score: 33.75

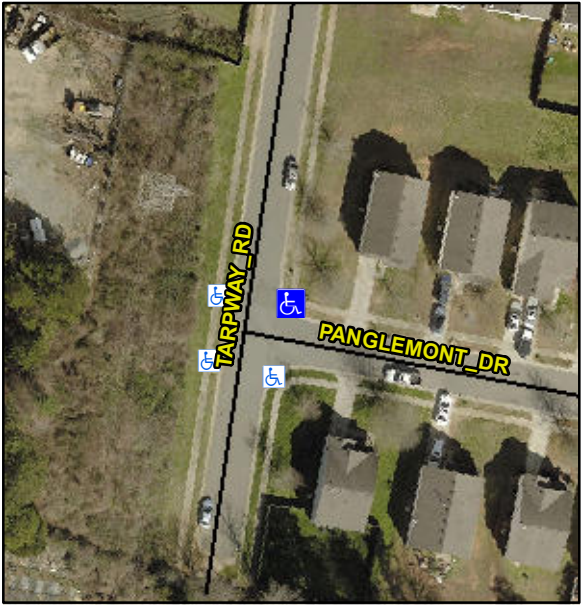
Possible Solutions:		Compliance	Description	Data
	Remove & Replace Curb Ramp With Two New Directional Ramps or Equivalent.		N/A	Ramp Length (in)	48.0
			No	Ramp Width (in)	43.0
			N/A	Flare Type LT	N/A
			N/A	Flare Slope LT (%)	N/A
			N/A	Flare Traversable LT?	N/A
			N/A	Landing Length (in)	N/A
			N/A	Landing Width (in)	N/A
			N/A	Landing Slope (%)	N/A
			N/A	Landing X Slope (%)	N/A
			N/A	Landing Curb? (Y/N)	N/A
			N/A	Shared Landing?	N/A
			N/A	Gutter Ponding?	N/A
			N/A	Gutter Lip Ht (in)	N/A
			N/A	Painted X Walk1?	No
				X Walk 1 Direction	To W
			N/A	X Walk 1 Width (in)	N/A
				X Walk 1 Slope (%)	7.0
				X Walk 1 X Slope (%)	3.0
			N/A	Ramp inside XWalk1?	N/A
<p>Surveyor Notes:</p> <p>N/A</p> <p>PROW/ADA:</p> <p>Not Found, R304.5.1, R304.5.3</p>			N/A	Flare Type RT	N/A
			N/A	Flare Slope RT (%)	N/A
			N/A	Flare Traversable RT?	N/A

N/A	DWS Provided?	N/A
			N/A	DWS Contrast?	N/A
			N/A	DWS Length (in)	N/A
			N/A	DWS Full Width?	N/A
			N/A	DWS Offset (in)	N/A
			N/A	Gutter Slope (%)	N/A
			N/A	Gutter X Slope (%)	N/A
			N/A	Painted X Walk2?	No
				X Walk 2 Direction	To S
			N/A	X Walk 2 Width (in)	N/A
				X Walk 2 Slope (%)	2.1
				X Walk 2 X Slope (%)	10.0
			N/A	Ramp inside XWalk2?	N/A
			N/A	Clear Space?	N/A
			N/A	Clear Space to XWalk (in)	N/A
			N/A	Storm Grate/Utility Hazard?	N/A
				Storm Grate/Utility Type	
			N/A		N/A
			Yes	Surface Condition? (G/P)	Good
Total Cost:		\$ 3200.00
