Access Compliance Report

Public Rights-of-Way

(Curb Ramps)

Intersection ID: 15763	Main Street: MONROE_RD	Cross Street: N_WENDOVER_RD	Location: E
ADA ID: ED1A4B316845	Ramp Type: Perp	Initial Pass/Fail: Fail	Overall Compliance: No
		Severity Score: 10

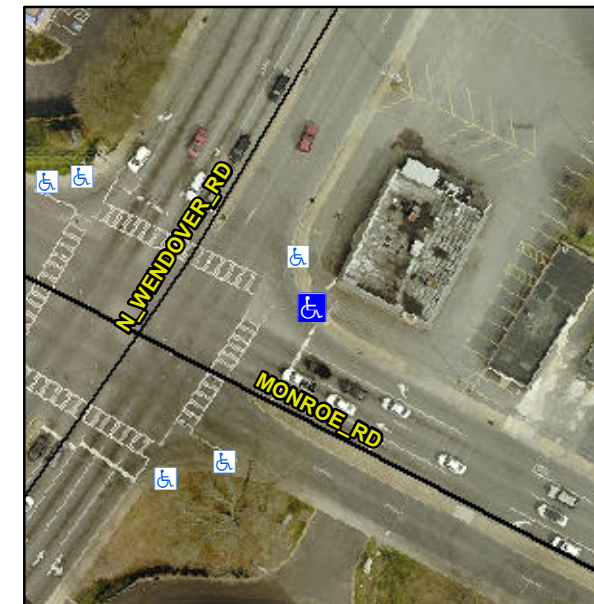
Not Found, R304.5.1, R304.5.3

Compliance	Description	Data	Compliance	Description	Data
N/A	Ramp Length (in)	59.0	Yes	Ramp Slope (%)	6.5
No	Ramp Width (in)	42.0	No	Ramp XSlope (%)	2.5
N/A	Flare Type LT	N/A	N/A	Flare Type RT	N/A
N/A	Flare Slope LT (%)	N/A	N/A	Flare Slope RT (%)	N/A
N/A	Flare Traversable LT?	N/A	N/A	Flare Traversable RT?	N/A
N/A	Landing Length (in)	N/A	N/A	DWS Provided?	N/A
N/A	Landing Width (in)	N/A	N/A	DWS Contrast?	N/A
N/A	Landing Slope (%)	N/A	N/A	DWS Length (in)	N/A
N/A	Landing X Slope (%)	N/A	N/A	DWS Full Width?	N/A
N/A	Landing Curb? (Y/N)	N/A	N/A	DWS Offset (in)	N/A
N/A	Shared Landing?	N/A			
N/A	Gutter Ponding?	N/A	N/A	Gutter Slope (%)	N/A
N/A	Gutter Lip Ht (in)	N/A	N/A	Gutter X Slope (%)	N/A
N/A	Painted X Walk1?	Yes	N/A	Painted X Walk2?	N/A
	X Walk 1 Direction	To SW		X Walk 2 Direction	N/A
N/A	X Walk 1 Width (in)	108.0	N/A	X Walk 2 Width (in)	N/A
	X Walk 1 Slope (%)	0.0		X Walk 2 Slope (%)	N/A
	X Walk 1 X Slope (%)	1.9		X Walk 2 X Slope (%)	N/A

N/A	Ramp inside XWalk1?	Yes	N/A	Ramp inside XWalk2?	N/A
	Road Slope (%)	N/A	N/A	Clear Space?	N/A
	Road X Slope (%)	N/A	N/A	Clear Space to XWalk (in)	N/A
N/A	Any Obstructions?	N/A	N/A	Storm Grate/Utility Hazard?	N/A
	Obstruction Type			Storm Grate/Utility Type	
		N/A			N/A
		Yes		Surface Condition? (G/P)	Good

Remove & Replace Entire Ramp.

Total Cost: \$ 1850.00
