## **Access Compliance Report Public Rights-of-Way** (Curb Ramps)

Intersection ID: 13559 Main Street: W\_WORTHINGTON\_AV Cross Street: WEST\_BV Location: NE ADA ID: ED1A531B3CD2 Ramp Type: Perp Initial Pass/Fail: Fail **Overall Compliance: No Severity Score:** 8.75

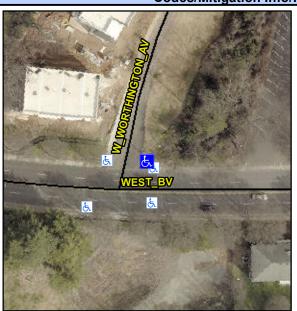
| " | 1 0001810 001411011 | |
|---|---|---|
| - | Not Found, R304.5.1 | N/A |

| Field Measurements/Component Compliance | | | | | | | | | |
|---|---|---|---|---|---|---|--|--|--|
| No | Ramp Width (in) | 43.0 | Yes | Ramp | XSlope (%) | 1.1 | | | |

| " | 1 0001810 001411011 | |
|---|---|---|
| | Remove & Replace Entire Ramp. | N/A |

1850.00
