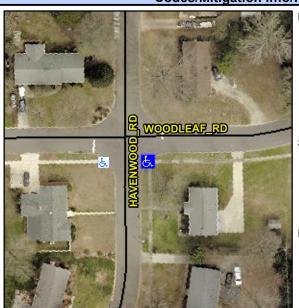
Intersection ID: 13433Main Street: HAVENWOOD_RDCross Street: WOODLEAF_RDLocation:SEADA ID: ED1ED4CA834ERamp Type: PerpInitial Pass/Fail: FailOverall Compliance: NoSeverity Score:10

Field Measurements/Component Compliance						
Comp	liance Description	Data	Comp	liance Description	Data	
N/A	Ramp Length (in)	53.5	Yes	Ramp Slope (%)	7.9	
No	Ramp Width (in)	41.0	Yes	Ramp XSlope (%)	4.3	
N/A	Flare Type LT	N/A	N/A	Flare Type RT	N/A	
N/A	Flare Slope LT (%)	N/A	N/A	Flare Slope RT (%)	N/A	
N/A	Flare Traversable LT?	N/A	N/A	Flare Traversable RT?	N/A	
N/A	Landing Length (in)	N/A	N/A	DWS Provided?	N/A	
N/A	Landing Width (in)	N/A	N/A	DWS Contrast?	N/A	
N/A	Landing Slope (%)	N/A	N/A	DWS Length (in)	N/A	
N/A	Landing X Slope (%)	N/A	N/A	DWS Full Width?	N/A	
N/A	Landing Curb? (Y/N)	N/A	N/A	DWS Offset (in)	N/A	
N/A	Shared Landing?	N/A				
N/A	Gutter Ponding?	N/A	N/A	Gutter Slope (%)	N/A	
N/A	Gutter Lip Ht (in)	N/A	N/A	Gutter X Slope (%)	N/A	
N/A	Painted X Walk1?	No	N/A	Painted X Walk2?	N/A	
	X Walk 1 Direction	To W		X Walk 2 Direction	N/A	
N/A	X Walk 1 Width (in)	N/A	N/A	X Walk 2 Width (in)	N/A	
	X Walk 1 Slope (%)	11.2		X Walk 2 Slope (%)	N/A

X Walk 1 X Slope (%)	4.3		X Walk 2 X Slope (%)	N/A	
N/A	Ramp inside XWalk1?	N/A	N/A	Ramp inside XWalk2?	N/A	
	Road Slope (%)	4.3	N/A	Clear Space?	N/A	
	Road X Slope (%)	11.2	N/A	Clear Space to XWalk (in)	N/A	
N/A	Any Obstructions?	N/A	N/A	Storm Grate/Utility Hazard?	N/A	
	Obstruction Type			Storm Grate/Utility Type		
		N/A			N/A	
			Yes	Surface Condition? (G/P)	Good	
THE	1

Remove & Replace Entire Ramp.

R304.5.1
