Access Compliance Report

Public Rights-of-Way

(Curb Ramps)

Intersection ID: 11322	Main Street: N_GRAHAM_ST	Cross Street: W_10TH_ST	Location: N
ADA ID: ED304C24E80E	Ramp Type: Perp	Initial Pass/Fail: Fail	Overall Compliance: No
Severity Score: 10			
Codes/Mitigation Info/Possible Solution		Field Measurements/Component Compliance

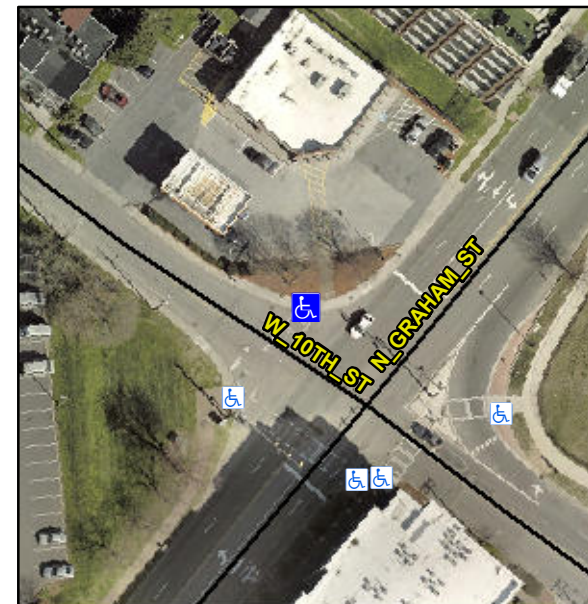
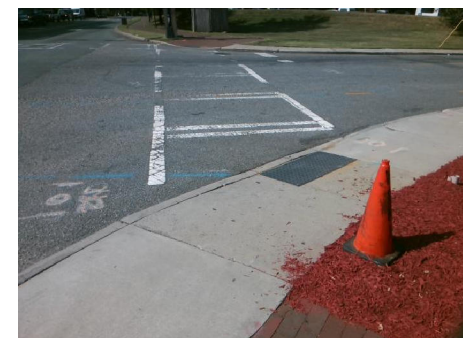
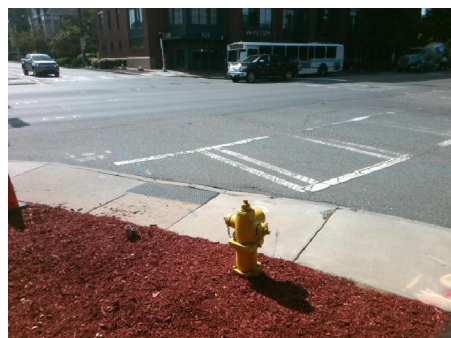
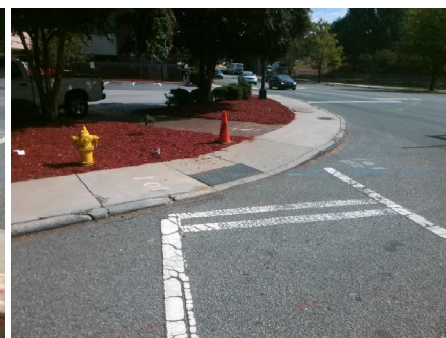
Compliance	Description	Data	Compliance	Description	Data
N/A	Ramp Length (in)	60.0	Yes	Ramp Slope (%)	7.5
No	Ramp Width (in)	43.0	Yes	Ramp XSlope (%)	2.7
N/A	Flare Type LT	N/A	N/A	Flare Type RT	N/A
N/A	Flare Slope LT (%)	N/A	N/A	Flare Slope RT (%)	N/A
N/A	Flare Traversable LT?	N/A	N/A	Flare Traversable RT?	N/A
N/A	Landing Length (in)	N/A	N/A	DWS Provided?	N/A
N/A	Landing Width (in)	N/A	N/A	DWS Contrast?	N/A
N/A	Landing Slope (%)	N/A	N/A	DWS Length (in)	N/A
N/A	Landing X Slope (%)	N/A	N/A	DWS Full Width?	N/A
N/A	Landing Curb? (Y/N)	N/A	N/A	DWS Offset (in)	N/A
N/A	Shared Landing?	N/A			
N/A	Gutter Ponding?	N/A	N/A	Gutter Slope (%)	N/A
N/A	Gutter Lip Ht (in)	N/A	N/A	Gutter X Slope (%)	N/A
N/A	Painted X Walk1?	Yes	N/A	Painted X Walk2?	N/A
	X Walk 1 Direction	To SW		X Walk 2 Direction	N/A
N/A	X Walk 1 Width (in)	107.0	N/A	X Walk 2 Width (in)	N/A
	X Walk 1 Slope (%)	1.4		X Walk 2 Slope (%)	N/A
	X Walk 1 X Slope (%)	3.0		X Walk 2 X Slope (%)	N/A

N/A	Ramp inside XWalk1?	Yes	N/A	Ramp inside XWalk2?	N/A
	Road Slope (%)	N/A	N/A	Clear Space?	N/A
	Road X Slope (%)	N/A	N/A	Clear Space to XWalk (in)	N/A
N/A	Any Obstructions?	N/A	N/A	Storm Grate/Utility Hazard?	N/A
	Obstruction Type			Storm Grate/Utility Type	
		N/A			N/A
			Yes	Surface Condition? (G/P)	Good

Possible Solutions:

Remove & Replace Entire Ramp.

R304.5.1
