Access Compliance Report

Public Rights-of-Way

(Curb Ramps)

Intersection ID: 14692	Main Street: QUEENS_RD	Cross Street: DARTMOUTH_PL	Location: SE
ADA ID: ED37345B4253	Ramp Type: PerpDiag	Initial Pass/Fail: Fail	Overall Compliance: No
		Severity Score: 12.5

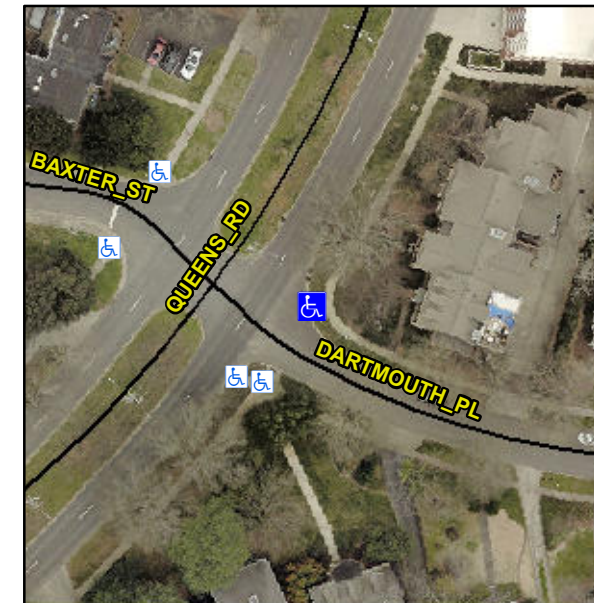
Compliance	Description	Data	Compliance	Description	Data
N/A	Ramp Length (in)	105.0	Yes	Ramp Slope (%)	5.4
Yes	Ramp Width (in)	60.0	No	Ramp XSlope (%)	5.2
N/A	Flare Type LT	N/A	N/A	Flare Type RT	N/A
N/A	Flare Slope LT (%)	N/A	N/A	Flare Slope RT (%)	N/A
N/A	Flare Traversable LT?	N/A	N/A	Flare Traversable RT?	N/A
N/A	Landing Length (in)	N/A	N/A	DWS Provided?	N/A
N/A	Landing Width (in)	N/A	N/A	DWS Contrast?	N/A
N/A	Landing Slope (%)	N/A	N/A	DWS Length (in)	N/A
N/A	Landing X Slope (%)	N/A	N/A	DWS Full Width?	N/A
N/A	Landing Curb? (Y/N)	N/A	N/A	DWS Offset (in)	N/A
N/A	Shared Landing?	N/A			
N/A	Gutter Ponding?	N/A	N/A	Gutter Slope (%)	N/A
N/A	Gutter Lip Ht (in)	N/A	N/A	Gutter X Slope (%)	N/A
N/A	Painted X Walk1?	No	N/A	Painted X Walk2?	No
	X Walk 1 Direction	To NW		X Walk 2 Direction	To SW
N/A	X Walk 1 Width (in)	N/A	N/A	X Walk 2 Width (in)	N/A
	X Walk 1 Slope (%)	3.3		X Walk 2 Slope (%)	2.2
	X Walk 1 X Slope (%)	3.5		X Walk 2 X Slope (%)	6.5

N/A	Ramp inside XWalk1?	N/A	N/A	Ramp inside XWalk2?	N/A
	Road Slope (%)	5.7	N/A	Clear Space?	N/A
	Road X Slope (%)	4.0	N/A	Clear Space to XWalk (in)	N/A
N/A	Any Obstructions?	N/A	N/A	Storm Grate/Utility Hazard?	N/A
	Obstruction Type			Storm Grate/Utility Type	
		N/A			N/A
			Yes	Surface Condition? (G/P)	Good

Remove & Replace Curb Ramp With Two New Directional Ramps or Equivalent.

R304.5.3
