# Access Compliance Report

## Public Rights-of-Way (Curb Ramps)

Intersection ID: 10577	Main Street: JORDAN_PL	Cross Street: N/A	Location: NW
ADA ID: ED43ECE9B8D9	Ramp Type: PerpDiag	Initial Pass/Fail: Fail	Overall Compliance: No
			Severity Score: 21.25

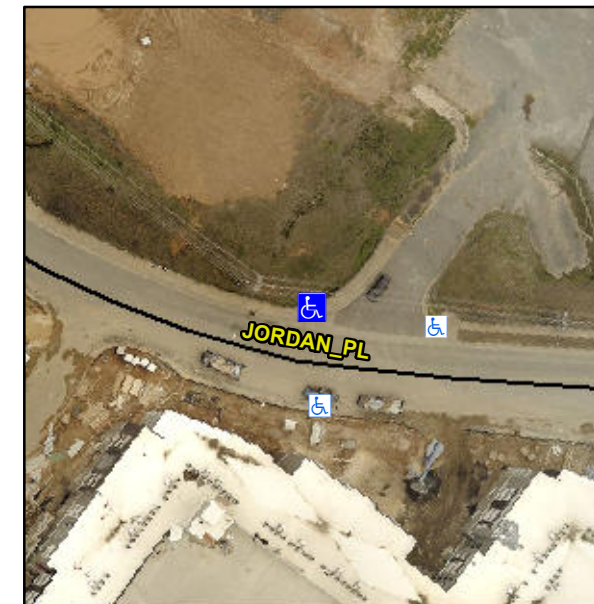
**Not Found, R304.5.1, R304.5.3**

Compliance	Description	Data	Compliance	Description	Data
N/A	Ramp Length (in)	72.0	Yes	Ramp Slope (%)	7.5
No	Ramp Width (in)	39.5	No	Ramp XSlope (%)	5.3
N/A	Flare Type LT	N/A	N/A	Flare Type RT	N/A
N/A	Flare Slope LT (%)	N/A	N/A	Flare Slope RT (%)	N/A
N/A	Flare Traversable LT?	N/A	N/A	Flare Traversable RT?	N/A
N/A	Landing Length (in)	N/A	N/A	DWS Provided?	N/A
N/A	Landing Width (in)	N/A	N/A	DWS Contrast?	N/A
N/A	Landing Slope (%)	N/A	N/A	DWS Length (in)	N/A
N/A	Landing X Slope (%)	N/A	N/A	DWS Full Width?	N/A
N/A	Landing Curb? (Y/N)	N/A	N/A	DWS Offset (in)	N/A
N/A	Shared Landing?	N/A			
N/A	Gutter Ponding?	N/A	N/A	Gutter Slope (%)	N/A
N/A	Gutter Lip Ht (in)	N/A	N/A	Gutter X Slope (%)	N/A
N/A	Painted X Walk1?	No	N/A	Painted X Walk2?	No
	X Walk 1 Direction	To SW		X Walk 2 Direction	To SE
N/A	X Walk 1 Width (in)	N/A	N/A	X Walk 2 Width (in)	N/A
	X Walk 1 Slope (%)	1.9		X Walk 2 Slope (%)	1.6
	X Walk 1 X Slope (%)	1.2		X Walk 2 X Slope (%)	8.8

N/A	Ramp inside XWalk1?	N/A	N/A	Ramp inside XWalk2?	N/A
	Road Slope (%)	2.1	N/A	Clear Space?	N/A
	Road X Slope (%)	1.0	N/A	Clear Space to XWalk (in)	N/A
N/A	Any Obstructions?	N/A	N/A	Storm Grate/Utility Hazard?	N/A
	Obstruction Type			Storm Grate/Utility Type	
		N/A			N/A
			Yes	Surface Condition? (G/P)	Good

**Remove & Replace Curb Ramp With Two New Directional Ramps or Equivalent.**

Total Cost: \$ 3200.00
