Access Compliance Report

Public Rights-of-Way

(Curb Ramps)

Intersection ID: 22882	Main Street: SARDIS_POINTE_RD	Cross Street: SARDIS_RD	Location: S
ADA ID: ED47E64A6A10	Ramp Type: Perp	Initial Pass/Fail: Fail	Overall Compliance: No
Severity Score: 33.75			
Codes/Mitigation Info/Possible Solution		Field Measurements/Component Compliance

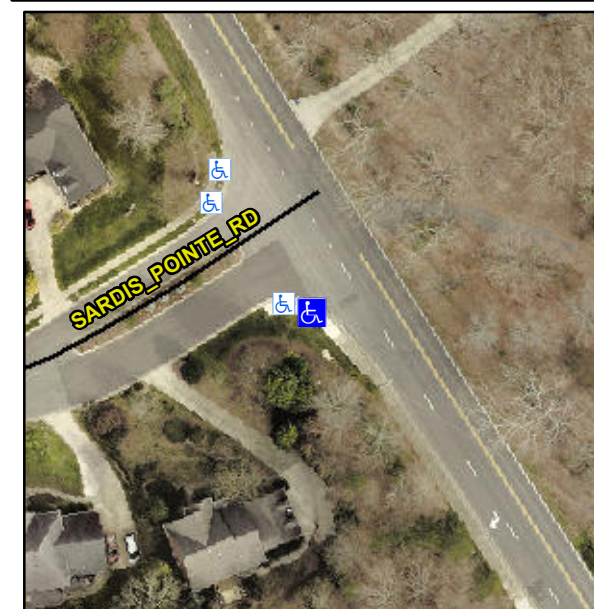
Compliance	Description	Data	Compliance	Description	Data
N/A	Ramp Length (in)	71.0	Yes	Ramp Slope (%)	5.1
No	Ramp Width (in)	46.0	No	Ramp XSlope (%)	8.1
N/A	Flare Type LT	N/A	N/A	Flare Type RT	N/A
N/A	Flare Slope LT (%)	N/A	N/A	Flare Slope RT (%)	N/A
N/A	Flare Traversable LT?	N/A	N/A	Flare Traversable RT?	N/A
N/A	Landing Length (in)	N/A	N/A	DWS Provided?	N/A
N/A	Landing Width (in)	N/A	N/A	DWS Contrast?	N/A
N/A	Landing Slope (%)	N/A	N/A	DWS Length (in)	N/A
N/A	Landing X Slope (%)	N/A	N/A	DWS Full Width?	N/A
N/A	Landing Curb? (Y/N)	N/A	N/A	DWS Offset (in)	N/A
N/A	Shared Landing?	N/A			
N/A	Gutter Ponding?	N/A	N/A	Gutter Slope (%)	N/A
N/A	Gutter Lip Ht (in)	N/A	N/A	Gutter X Slope (%)	N/A
N/A	Painted X Walk1?	No	N/A	Painted X Walk2?	N/A
	X Walk 1 Direction	To NE		X Walk 2 Direction	N/A
N/A	X Walk 1 Width (in)	N/A	N/A	X Walk 2 Width (in)	N/A
	X Walk 1 Slope (%)	7.0		X Walk 2 Slope (%)	N/A
	X Walk 1 X Slope (%)	3.7		X Walk 2 X Slope (%)	N/A

N/A	Ramp inside XWalk1?	N/A	N/A	Ramp inside XWalk2?	N/A
	Road Slope (%)	N/A	N/A	Clear Space?	N/A
	Road X Slope (%)	N/A	N/A	Clear Space to XWalk (in)	N/A
N/A	Any Obstructions?	N/A	N/A	Storm Grate/Utility Hazard?	N/A
	Obstruction Type			Storm Grate/Utility Type	
		N/A			N/A
			Yes	Surface Condition? (G/P)	Good

Possible Solutions:

Remove & Replace Entire Ramp.
