Access Compliance Report Public Rights-of-Way (Curb Ramps)

Main Street: ROBINSON_CHURCH_RD Cross Street: TEANECK PL Location: Intersection ID: 12114 NE Initial Pass/Fail: Fail **Overall Compliance: No** ADA ID: ED4A80311338 Ramp Type: Combination2 **Severity Score:** 37.5

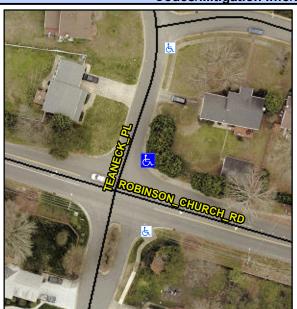
Street 1 Name None Stop Condition-Street 1 **ROBINSON CHURCH RD** N/A Street 2 Name Stop Condition-Street 2 N/A Possible Solutions: Compliance Description Remove & Replace Entire Ramp. N/A N/A N/A N/A N/A Yes Surveyor Notes: N/A DAMAGED CURB, LT RP < 5% N/A N/A N/A N/A PROW/ADA: N/A Not Found, R304.5.3, R304.3.2 N/A N/A N/A N/A N/A N/A
