Access Compliance Report

Public Rights-of-Way

(Curb Ramps)

Intersection ID: 2696	Main Street: HAWKSNEST_DR	Cross Street: RAVENCREST_DR	Location: SE
ADA ID: ED59581D26D7	Ramp Type: PerpDiag	Initial Pass/Fail: Pass	Overall Compliance: No
Severity Score: 10.25			
Codes/Mitigation Info/Possible Solution		Field Measurements/Component Compliance

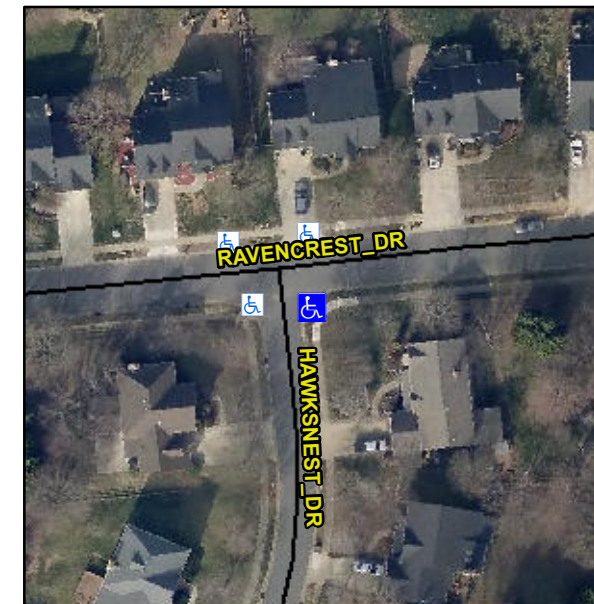
Compliance	Description	Data	Compliance	Description	Data
N/A	Ramp Length (in)	48.0	Yes	Ramp Slope (%)	6.9
Yes	Ramp Width (in)	72.0	No	Ramp XSlope (%)	2.9
N/A	Flare Type LT	None	N/A	Flare Type RT	N/A
N/A	Flare Slope LT (%)	N/A	N/A	Flare Slope RT (%)	N/A
N/A	Flare Traversable LT?	N/A	N/A	Flare Traversable RT?	N/A
Yes	Landing Length (in)	49.5	No	DWS Provided?	No
No	Landing Width (in)	39.0	N/A	DWS Contrast?	No
No	Landing Slope (%)	5.0	N/A	DWS Length (in)	N/A
Yes	Landing X Slope (%)	2.0	N/A	DWS Full Width?	No
N/A	Landing Curb? (Y/N)	No	N/A	DWS Offset (in)	N/A
N/A	Shared Landing?	No			
Yes	Gutter Ponding?	No	Yes	Gutter Slope (%)	4.7
Yes	Gutter Lip Ht (in)	0.0	No	Gutter X Slope (%)	3.1
N/A	Painted X Walk1?	No	N/A	Painted X Walk2?	No
	X Walk 1 Direction	To N		X Walk 2 Direction	To W
N/A	X Walk 1 Width (in)	N/A	N/A	X Walk 2 Width (in)	N/A
	X Walk 1 Slope (%)	1.5		X Walk 2 Slope (%)	2.0
	X Walk 1 X Slope (%)	1.9		X Walk 2 X Slope (%)	1.7

N/A	Ramp inside XWalk1?	N/A	N/A	Ramp inside XWalk2?	N/A
	Road Slope (%)	1.9	N/A	Clear Space?	Yes
	Road X Slope (%)	2.4	N/A	Clear Space to XWalk (in)	N/A
Yes	Any Obstructions?	No	Yes	Storm Grate/Utility Hazard?	No
	Obstruction Type			Storm Grate/Utility Type	
		N/A			N/A
			Yes	Surface Condition? (G/P)	Good

Remove & Replace Curb Ramp With Two New Directional Ramps or Equivalent. Remove & Replace Gutter.
