Access Compliance Report

Public Rights-of-Way

(Curb Ramps)

Intersection ID: 49801	Main Street: PARSIFAL_LN	Cross Street: GANDOLFO_CT	Location: S
ADA ID: ED654EF3C1B5	Ramp Type: Perp	Initial Pass/Fail: Fail	Overall Compliance: No
Codes/Mitigation Info/Possible Solution		Field Measurements/Component Compliance

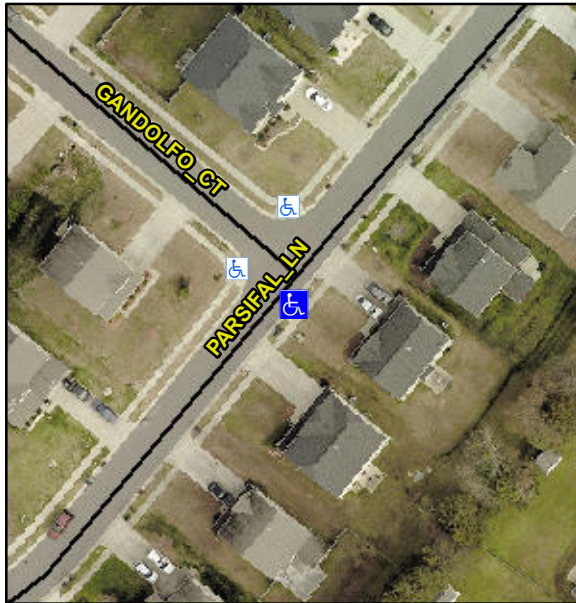
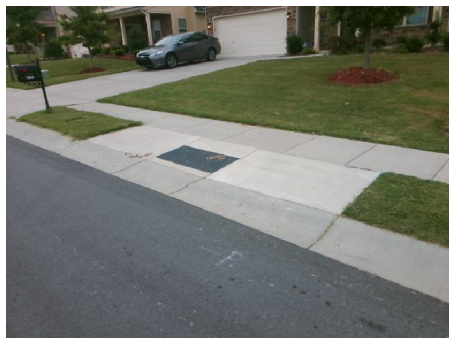
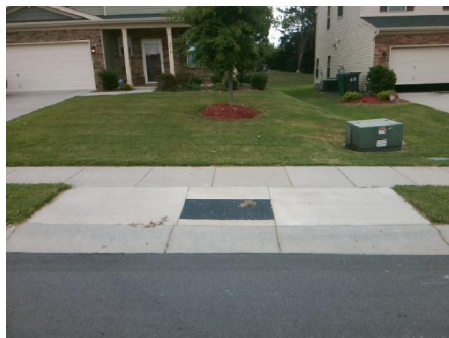
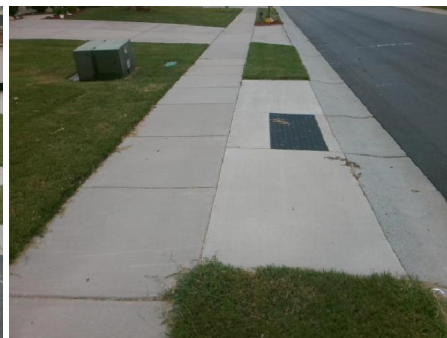
Not Found, R304.2.2, R304.5.3

Compliance	Description	Data	Compliance	Description	Data
N/A	Ramp Length (in)	58.0	No	Ramp Slope (%)	9.4
Yes	Ramp Width (in)	48.0	No	Ramp XSlope (%)	3.5
N/A	Flare Type LT	N/A	N/A	Flare Type RT	N/A
N/A	Flare Slope LT (%)	N/A	N/A	Flare Slope RT (%)	N/A
N/A	Flare Traversable LT?	N/A	N/A	Flare Traversable RT?	N/A
N/A	Landing Length (in)	N/A	N/A	DWS Provided?	N/A
N/A	Landing Width (in)	N/A	N/A	DWS Contrast?	N/A
N/A	Landing Slope (%)	N/A	N/A	DWS Length (in)	N/A
N/A	Landing X Slope (%)	N/A	N/A	DWS Full Width?	N/A
N/A	Landing Curb? (Y/N)	N/A	N/A	DWS Offset (in)	N/A
N/A	Shared Landing?	N/A			
N/A	Gutter Ponding?	N/A	N/A	Gutter Slope (%)	N/A
N/A	Gutter Lip Ht (in)	N/A	N/A	Gutter X Slope (%)	N/A
N/A	Painted X Walk1?	No	N/A	Painted X Walk2?	N/A
	X Walk 1 Direction	To NW		X Walk 2 Direction	N/A
N/A	X Walk 1 Width (in)	N/A	N/A	X Walk 2 Width (in)	N/A
	X Walk 1 Slope (%)	3.0		X Walk 2 Slope (%)	N/A
	X Walk 1 X Slope (%)	3.3		X Walk 2 X Slope (%)	N/A

N/A	Ramp inside XWalk1?	N/A	N/A	Ramp inside XWalk2?	N/A
	Road Slope (%)	N/A	N/A	Clear Space?	N/A
	Road X Slope (%)	N/A	N/A	Clear Space to XWalk (in)	N/A
N/A	Any Obstructions?	N/A	N/A	Storm Grate/Utility Hazard?	N/A
	Obstruction Type			Storm Grate/Utility Type	
		N/A			N/A
			Yes	Surface Condition? (G/P)	Good

Remove & Replace Entire Ramp.
