Access Compliance Report

Public Rights-of-Way

(Curb Ramps)

Intersection ID: 10031454	Main Street: MCDONALD_AV	Cross Street: N/A	Location: W
ADA ID: ED71880DF072	Ramp Type: Combination2	Initial Pass/Fail: Fail	Overall Compliance: No
			Severity Score: 43.75

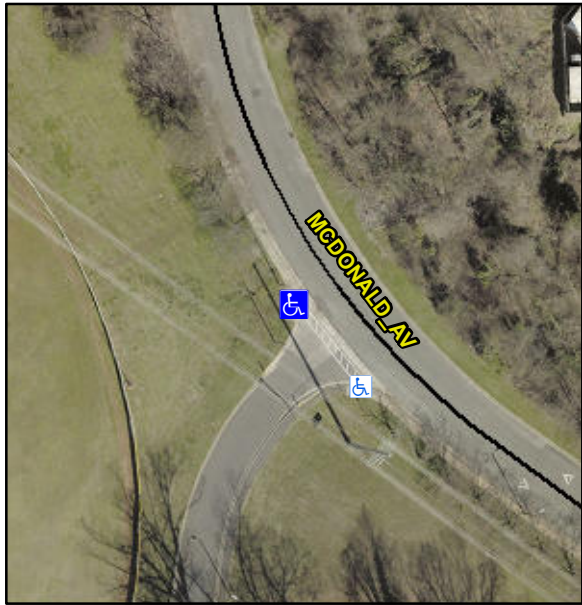
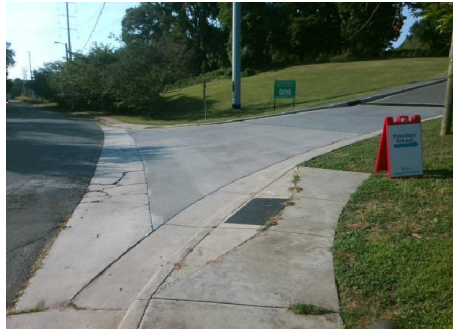
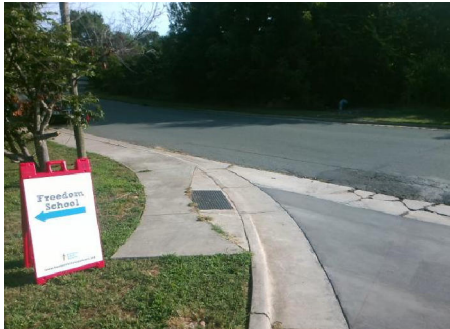
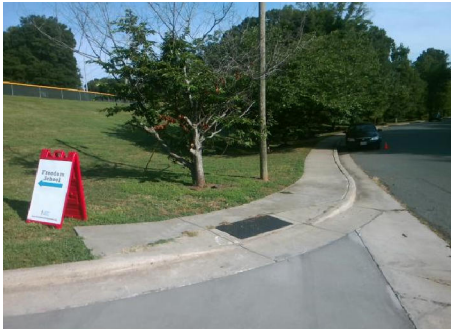
Possible Solutions:			Compliance	Description	Data	Compliance	Description	Data
	Remove & Replace Entire Ramp.			N/A	Ramp Length LT (in)	64.0	N/A	Ramp Length RT (in)	N/A
				No	Ramp Width LT (in)	34.0	N/A	Ramp Width RT (in)	N/A
				No	Ramp Slope LT (%)	12.1	N/A	Ramp Slope RT (%)	N/A
				Yes	Ramp XSlope LT (%)	1.4	N/A	Ramp XSlope RT (%)	N/A
				N/A	Ramp Length (in)	26.0	No	Ramp Slope (%)	9.7
				Yes	Ramp Width (in)	59.0	No	Ramp XSlope (%)	3.5
	Surveyor Notes:			N/A	Flare Type LT	N/A	N/A	Flare Type RT	N/A
	N/A			N/A	Flare Slope LT (%)	N/A	N/A	Flare Slope RT (%)	N/A
				N/A	Flare Traversable LT?	N/A	N/A	Flare Traversable RT?	N/A
PROW/ADA:			N/A	Landing Length (in)	N/A	N/A	DWS Provided?	N/A	
Not Found, R304.5.1, R304.2.2, R304.5.3, R304.3.2			N/A	Landing Width (in)	N/A	N/A	DWS Contrast?	N/A	
			N/A	Landing Slope (%)	N/A	N/A	DWS Length (in)	N/A

N/A	Landing X Slope (%)	N/A	N/A	DWS Full Width?	N/A	
			N/A	Landing Curb? (Y/N)	N/A	N/A	DWS Offset (in)	N/A	
			N/A	Shared Landing?	N/A				
			N/A	Gutter Ponding?	N/A	N/A	Gutter Slope (%)	N/A	
			N/A	Gutter Lip Ht (in)	N/A	N/A	Gutter X Slope (%)	N/A	
			N/A	Painted X Walk1?	No	N/A	Painted X Walk2?	N/A	
				X Walk 1 Direction	To SE		X Walk 2 Direction	N/A	
				X Walk 1 Width (in)	N/A		X Walk 2 Width (in)	N/A	
				X Walk 1 Slope (%)	0.0		X Walk 2 Slope (%)	N/A	
				X Walk 1 X Slope (%)	9.3		X Walk 2 X Slope (%)	N/A	
			N/A	Ramp inside XWalk1?	N/A	N/A	Ramp inside XWalk2?	N/A	
				Road Slope (%)	N/A		Clear Space?	N/A	
				Road X Slope (%)	N/A	N/A	Clear Space to XWalk (in)	N/A	
						N/A	Any Obstruction?	N/A	
							Obstruction Type	N/A	
						N/A	Storm Grate/Utility Hazard?	N/A	
							Storm Grate/Utility Type	N/A	
						Yes	Surface Condition? (G/P)	Good	
							Curb Slope (%)	6.2	
Street 1 Name			StopSign
