Intersection ID: 17139	Main Street: BRIABEND_DR	Cross Street: SOUTH_BV	Location:	NE
ADA ID: ED80C7232D70	Ramp Type: ParaDiag	Initial Pass/Fail: Fail	Overall Compliance: No	Severity Score: 12.5

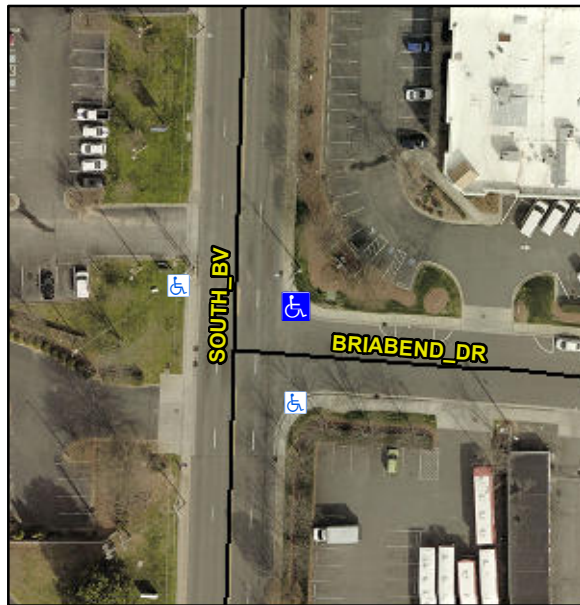
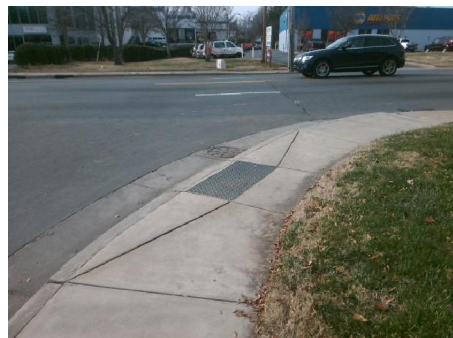
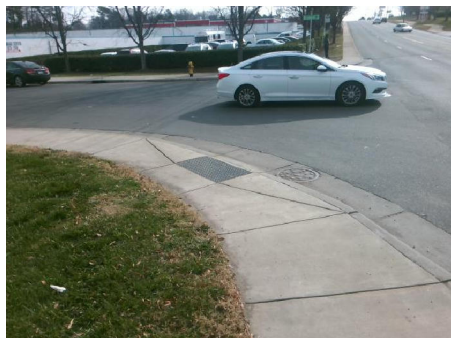
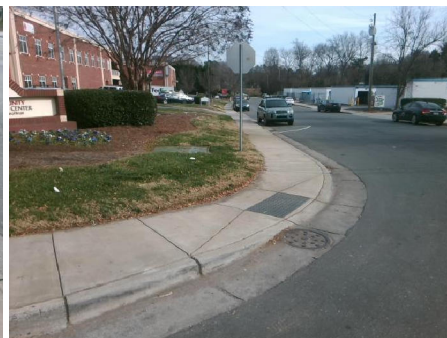
RT RP < 5%

R304.3.2

Compliance	Description	Data	Compliance	Description	Data
N/A	Ramp Length LT (in)	51.0	N/A	Ramp Length RT (in)	55.0
Yes	Ramp Width LT (in)	55.0	Yes	Ramp Width RT (in)	55.0
No	Ramp Slope LT (%)	9.0	Yes	Ramp Slope RT (%)	1.8
Yes	Ramp XSlope LT (%)	0.5	Yes	Ramp XSlope RT (%)	1.9
N/A	Landing Length (in)	N/A	N/A	DWS Provided?	N/A
N/A	Landing Width (in)	N/A	N/A	DWS Contrast?	N/A
N/A	Landing Slope (%)	N/A	N/A	DWS Length (in)	N/A
N/A	Landing X Slope (%)	N/A	N/A	DWS Full Width?	N/A
N/A	Landing Curb? (Y/N)	N/A	N/A	DWS Offset (in)	N/A
N/A	Shared Landing?	N/A			
N/A	Gutter Ponding?	N/A	N/A	Gutter Slope (%)	N/A
N/A	Gutter Lip Ht (in)	N/A	N/A	Gutter X Slope (%)	N/A
N/A	Painted X Walk1?	No	N/A	Painted X Walk2?	No
	X Walk 1 Direction	To W		X Walk 2 Direction	To S
N/A	X Walk 1 Width (in)	N/A	N/A	X Walk 2 Width (in)	N/A
	X Walk 1 Slope (%)	3.8		X Walk 2 Slope (%)	1.7
	X Walk 1 X Slope (%)	0.5		X Walk 2 X Slope (%)	3.9
N/A	Ramp inside XWalk1?	N/A	N/A	Ramp inside XWalk2?	N/A

Road Slope (%)	1.3	N/A	Clear Space?	N/A
	Road X Slope (%)	2.8	N/A	Clear Space to XWalk (in)	N/A
N/A	Any Obstructions?	N/A	N/A	Storm Grate/Utility Hazard?	N/A
	Obstruction Type			Storm Grate/Utility Type	
		N/A			N/A
			Yes	Surface Condition? (G/P)	Good
			N/A	Curb Slope (%)	17.3

Remove & Replace Curb Ramp With Two New Directional Ramps or Equivalent.
