Access Compliance Report Public Rights-of-Way (Curb Ramps)

Intersection ID: 10040992 Main Street: WALTON_RD **Cross Street: CHELVESTON_DR** Location:

Overall Compliance: No Severity Score: 25.25 **ADA ID: ED80D6241CE8** Ramp Type: Perp Initial Pass/Fail: Pass

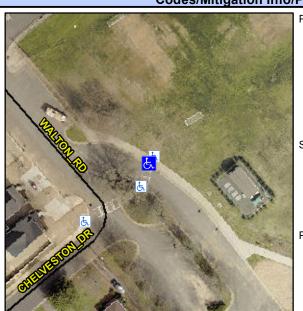
Field Measurements/Component Compliance							
Comp	liance Description	Data	Comp	oliance Description	Data		
N/A	Ramp Length (in)	101.0	Yes	Ramp Slope (%)	7.2		
Yes	Ramp Width (in)	48.0	Yes	Ramp XSlope (%)	3.2		
N/A	Flare Type LT	Sloped	N/A	Flare Type RT	N/A		
N/A	Flare Slope LT (%)	9.8	Yes	Flare Slope RT (%)	3.5		
N/A	Flare Traversable LT?	Yes	N/A	Flare Traversable RT?	Yes		
No	Landing Length (in)	N/A	Yes	DWS Provided?	Yes		
No	Landing Width (in)	N/A	Yes	DWS Contrast?	Yes		
No	Landing Slope (%)	N/A	Yes	DWS Length (in)	24.0		
No	Landing X Slope (%)	N/A	Yes	DWS Full Width?	Yes		
N/A	Landing Curb? (Y/N)	No	Yes	DWS Offset (in)	0.0		
N/A	Shared Landing?	No					
Yes	Gutter Ponding?	No	Yes	Gutter Slope (%)	4.9		
No	Gutter Lip Ht (in)	1.0	Yes	Gutter X Slope (%)	3.3		
N/A	Painted X Walk1?	Yes	N/A	Painted X Walk2?	N/A		
	X Walk 1 Direction	To SW		X Walk 2 Direction	N/A		
N/A	X Walk 1 Width (in)	96.0	N/A	X Walk 2 Width (in)	N/A

X Walk 1 Slope (%)	1.0		X Walk 2 Slope (%)	N/A		
	X Walk 1 X Slope (%)	3.4		X Walk 2 X Slope (%)	N/A		
Yes	Ramp inside XWalk1?	Yes	N/A	Ramp inside XWalk2?	N/A		
	Road Slope (%)	N/A	N/A	Clear Space?	Yes		
	Road X Slope (%)	N/A	N/A	Clear Space to XWalk (in)	N/A		
Yes	Any Obstructions?	No	Yes	Storm Grate/Utility Hazard?	No		
	Obstruction Type			Storm Grate/Utility Type			
		N/A			N/A		
			Yes	Surface Condition? (G/P)	Good		
	A second of the second

Possible Solutions:	
Remove & Replace Entire Ramp.	
Surveyor Notes:	
N/A	
PROW/ADA:	
Not Found, R304.2.1, R304.2.2-Perp,	
R304.3.2-Para, R304.5.3, R302.7.2	
I

Total Cost:	\$ 1850.00
