# Access Compliance Report

## Public Rights-of-Way

Intersection ID: 17770	Main Street: LORENE_AV	Cross Street: ROSWELL_AV	Location: SW
ADA ID: ED8328D44174	Ramp Type: Directional1	Initial Pass/Fail: Fail	Overall Compliance: No
		Severity Score: 25

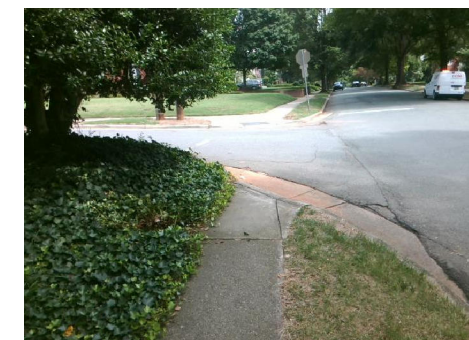
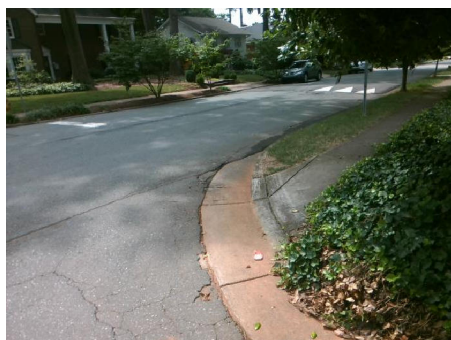
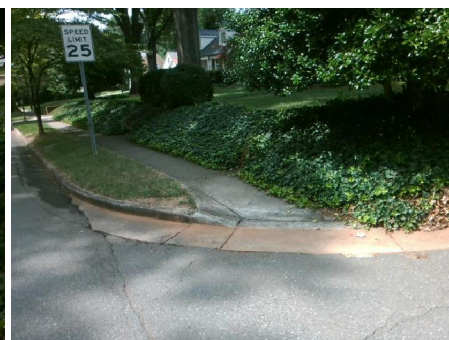
**VEGETATION OVERGROWTH**

Compliance	Description	Data	Compliance	Description	Data
N/A	Ramp Length (in)	63.0	N/A	Grade Break?	N/A
Yes	Ramp Width (in)	60.0	N/A	Grade Break Slope (%)	0.0
Yes	Ramp Slope (%)	5.3	N/A	Grade Break XSlope (%)	0.0
No	Ramp XSlope (%)	7.5			
N/A	Flare Type LT	N/A	N/A	Flare Type RT	N/A
N/A	Flare Slope LT (%)	N/A	N/A	Flare Slope RT (%)	0.0
N/A	Flare Traversable LT?	N/A	N/A	Flare Traversable RT?	N/A
N/A	Landing Length (in)	0.0	N/A	DWS Provided?	N/A
N/A	Landing Width (in)	0.0	N/A	DWS Contrast?	N/A
N/A	Landing Slope (%)	0.0	N/A	DWS Length (in)	N/A
N/A	Landing X Slope (%)	0.0	N/A	DWS Full Width?	N/A
N/A	Landing Curb? (Y/N)	N/A	N/A	DWS Offset LT (in)	N/A
N/A	Shared Landing?	N/A	N/A	DWS Offset RT (in)	N/A
N/A	Gutter Ponding?	0.0	N/A	Gutter Slope (%)	N/A
N/A	Gutter Lip Ht (in)	0.0	N/A	Gutter X Slope (%)	N/A
N/A	Painted X Walk1?	No		Road Slope (%)	3.2
	X Walk 1 Direction	To N		Road X Slope (%)	4.5
	X Walk 1 Width (in)	N/A		Clear Space?	N/A

**Remove & Replace Entire Ramp.**
