# Access Compliance Report

## Public Rights-of-Way

### (Curb Ramps)

Intersection ID: 42506	Main Street: CHASEWATER_DR	Cross Street: DARBY_CHASE_DR	Location: NE
ADA ID: EDA6CBD73146	Ramp Type: Perp	Initial Pass/Fail: Fail	Overall Compliance: No
			Severity Score: 21.25

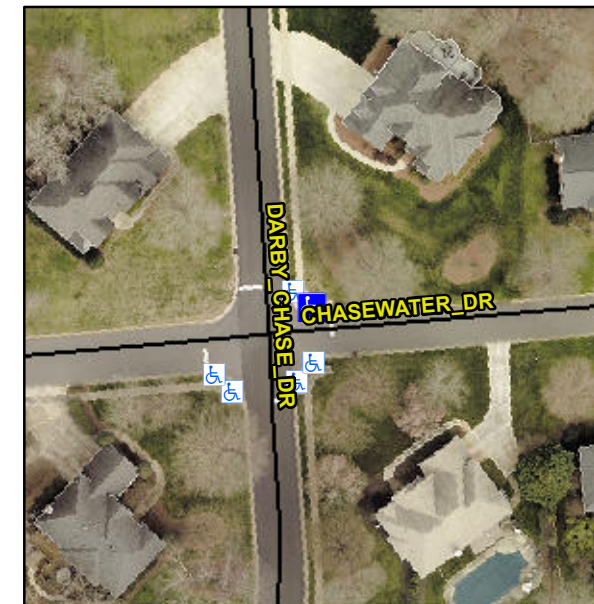
**Not Found, R304.5.1, R304.2.2**

Compliance	Description	Data	Compliance	Description	Data
N/A	Ramp Length (in)	46.0	No	Ramp Slope (%)	9.0
No	Ramp Width (in)	44.5	Yes	Ramp XSlope (%)	1.2
N/A	Flare Type LT	N/A	N/A	Flare Type RT	N/A
N/A	Flare Slope LT (%)	N/A	N/A	Flare Slope RT (%)	N/A
N/A	Flare Traversable LT?	N/A	N/A	Flare Traversable RT?	N/A
N/A	Landing Length (in)	N/A	N/A	DWS Provided?	N/A
N/A	Landing Width (in)	N/A	N/A	DWS Contrast?	N/A
N/A	Landing Slope (%)	N/A	N/A	DWS Length (in)	N/A
N/A	Landing X Slope (%)	N/A	N/A	DWS Full Width?	N/A
N/A	Landing Curb? (Y/N)	N/A	N/A	DWS Offset (in)	N/A
N/A	Shared Landing?	N/A			
N/A	Gutter Ponding?	N/A	N/A	Gutter Slope (%)	N/A
N/A	Gutter Lip Ht (in)	0.5	N/A	Gutter X Slope (%)	N/A
N/A	Painted X Walk1?	No	N/A	Painted X Walk2?	N/A
	X Walk 1 Direction	To S		X Walk 2 Direction	N/A
N/A	X Walk 1 Width (in)	N/A	N/A	X Walk 2 Width (in)	N/A
	X Walk 1 Slope (%)	0.9		X Walk 2 Slope (%)	N/A
	X Walk 1 X Slope (%)	0.6		X Walk 2 X Slope (%)	N/A

N/A	Ramp inside XWalk1?	N/A	N/A	Ramp inside XWalk2?	N/A
	Road Slope (%)	N/A	N/A	Clear Space?	N/A
	Road X Slope (%)	N/A	N/A	Clear Space to XWalk (in)	N/A
N/A	Any Obstructions?	N/A	N/A	Storm Grate/Utility Hazard?	N/A
	Obstruction Type			Storm Grate/Utility Type	
		N/A			N/A
			Yes	Surface Condition? (G/P)	Good

**Remove & Replace Entire Ramp.**
