Access Compliance Report

Public Rights-of-Way

(Curb Ramps)

Intersection ID: 7867	Main Street: BROOKTREE_DR	Cross Street: TODDVILLE_RD	Location: SE
ADA ID: EDA70D98C65D	Ramp Type: Perp	Initial Pass/Fail: Fail	Overall Compliance: No
Severity Score: 10			
Codes/Mitigation Info/Possible Solution		Field Measurements/Component Compliance

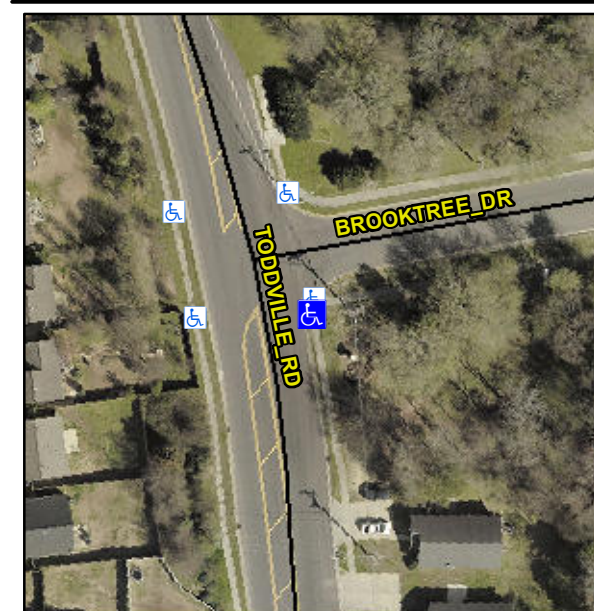
Not Found, R304.5.1

Compliance	Description	Data	Compliance	Description	Data
N/A	Ramp Length (in)	48.0	Yes	Ramp Slope (%)	5.0
No	Ramp Width (in)	47.0	Yes	Ramp XSlope (%)	4.1
N/A	Flare Type LT	N/A	N/A	Flare Type RT	N/A
N/A	Flare Slope LT (%)	N/A	N/A	Flare Slope RT (%)	N/A
N/A	Flare Traversable LT?	N/A	N/A	Flare Traversable RT?	N/A
N/A	Landing Length (in)	N/A	N/A	DWS Provided?	N/A
N/A	Landing Width (in)	N/A	N/A	DWS Contrast?	N/A
N/A	Landing Slope (%)	N/A	N/A	DWS Length (in)	N/A
N/A	Landing X Slope (%)	N/A	N/A	DWS Full Width?	N/A
N/A	Landing Curb? (Y/N)	N/A	N/A	DWS Offset (in)	N/A
N/A	Shared Landing?	N/A			
N/A	Gutter Ponding?	N/A	N/A	Gutter Slope (%)	N/A
N/A	Gutter Lip Ht (in)	N/A	N/A	Gutter X Slope (%)	N/A
N/A	Painted X Walk1?	No	N/A	Painted X Walk2?	N/A
	X Walk 1 Direction	To W		X Walk 2 Direction	N/A
N/A	X Walk 1 Width (in)	N/A	N/A	X Walk 2 Width (in)	N/A
	X Walk 1 Slope (%)	6.8		X Walk 2 Slope (%)	N/A
	X Walk 1 X Slope (%)	6.2		X Walk 2 X Slope (%)	N/A

N/A	Ramp inside XWalk1?	N/A	N/A	Ramp inside XWalk2?	N/A
	Road Slope (%)	N/A	N/A	Clear Space?	N/A
	Road X Slope (%)	N/A	N/A	Clear Space to XWalk (in)	N/A
N/A	Any Obstructions?	N/A	N/A	Storm Grate/Utility Hazard?	N/A
	Obstruction Type			Storm Grate/Utility Type	
		N/A			N/A
		Yes		Surface Condition? (G/P)	Good

Remove & Replace Entire Ramp.

Total Cost: \$ 1850.00
