# Access Compliance Report

## Public Rights-of-Way

### (Curb Ramps)

Intersection ID: 10057	Main Street: ANDRILL_TR	Cross Street: MADISON_AV	Location:	W
ADA ID: EDA758ADFE7A	Ramp Type: Combination1	Initial Pass/Fail: Fail	Overall Compliance: No	Severity Score: 67.5
Codes/Mitigation Info/Possible Solution		Field Measurements/Component Compliance

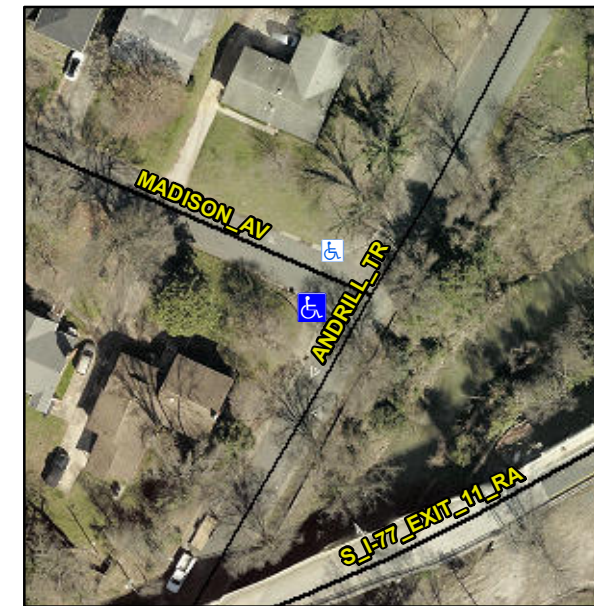
**LT RP < 5%**

**Not Found, R304.5.1, R304.2.2, R304.5.3, R304.3.2**

Compliance	Description	Data	Compliance	Description	Data
N/A	Ramp Length LT (in)	42.0	N/A	Ramp Length RT (in)	35.0
Yes	Ramp Width LT (in)	83.0	Yes	Ramp Width RT (in)	86.5
Yes	Ramp Slope LT (%)	1.7	No	Ramp Slope RT (%)	12.2
No	Ramp XSlope LT (%)	8.6	No	Ramp XSlope RT (%)	5.1
N/A	Ramp Length (in)	83.5	No	Ramp Slope (%)	12.3
No	Ramp Width (in)	34.0	No	Ramp XSlope (%)	4.2
N/A	Flare Type LT	N/A	N/A	Flare Type RT	N/A
N/A	Flare Slope LT (%)	N/A	N/A	Flare Slope RT (%)	N/A
N/A	Flare Traversable LT?	N/A	N/A	Flare Traversable RT?	N/A
N/A	Landing Length (in)	N/A	N/A	DWS Provided?	N/A
N/A	Landing Width (in)	N/A	N/A	DWS Contrast?	N/A
N/A	Landing Slope (%)	N/A	N/A	DWS Length (in)	N/A
N/A	Landing X Slope (%)	N/A	N/A	DWS Full Width?	N/A
N/A	Landing Curb? (Y/N)	N/A	N/A	DWS Offset (in)	N/A
N/A	Shared Landing?	N/A			
N/A	Gutter Ponding?	N/A	N/A	Gutter Slope (%)	N/A
N/A	Gutter Lip Ht (in)	N/A	N/A	Gutter X Slope (%)	N/A
N/A	Painted X Walk1?	No	N/A	Painted X Walk2?	N/A

X Walk 1 Direction	To NE		X Walk 2 Direction	N/A
	X Walk 1 Width (in)	N/A		X Walk 2 Width (in)	N/A
	X Walk 1 Slope (%)	2.9		X Walk 2 Slope (%)	N/A
	X Walk 1 X Slope (%)	2.3		X Walk 2 X Slope (%)	N/A
N/A	Ramp inside XWalk1?	N/A	N/A	Ramp inside XWalk2?	N/A
	Road Slope (%)	N/A		Clear Space?	N/A
	Road X Slope (%)	N/A	N/A	Clear Space to XWalk (in)	N/A
			N/A	Any Obstruction?	N/A
				Obstruction Type	N/A
			N/A	Storm Grate/Utility Hazard?	N/A
				Storm Grate/Utility Type	N/A
			Yes	Surface Condition? (G/P)	Good
				Curb Slope (%)	25.3

Possible Solutions:

**Remove & Replace Entire Ramp.**
