Access Compliance Report

Public Rights-of-Way

(Curb Ramps)

Intersection ID: 20967	Main Street: SHARON_VIEW_RD	Cross Street: MOUNTAINBROOK_RD	Location: NE
ADA ID: EDB61F1B4FC6	Ramp Type: Para	Initial Pass/Fail: Fail	Overall Compliance: No
Severity Score: 26.25			
Codes/Mitigation Info/Possible Solution		Field Measurements/Component Compliance

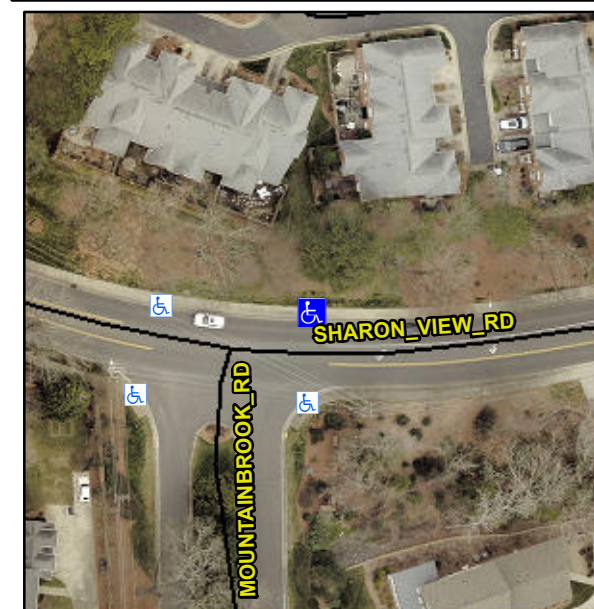
Surveyor Notes:

RT RP < 5%

PROW/ADA:

R304.3.2, R304.5.3

Compliance	Description	Data	Compliance	Description	Data
N/A	Ramp Length LT (in)	70.0	N/A	Ramp Length RT (in)	71.0
Yes	Ramp Width LT (in)	60.0	Yes	Ramp Width RT (in)	60.0
No	Ramp Slope LT (%)	13.1	Yes	Ramp Slope RT (%)	2.9
Yes	Ramp XSlope LT (%)	0.1	No	Ramp XSlope RT (%)	2.3
N/A	Landing Length (in)	N/A	N/A	DWS Provided?	N/A
N/A	Landing Width (in)	N/A	N/A	DWS Contrast?	N/A
N/A	Landing Slope (%)	N/A	N/A	DWS Length (in)	N/A
N/A	Landing X Slope (%)	N/A	N/A	DWS Full Width?	N/A
N/A	Landing Curb? (Y/N)	N/A	N/A	DWS Offset (in)	N/A
N/A	Shared Landing?	N/A			
N/A	Gutter Ponding?	N/A	N/A	Gutter Slope (%)	N/A
N/A	Gutter Lip Ht (in)	N/A	N/A	Gutter X Slope (%)	N/A
N/A	Painted X Walk1?	No	N/A	Painted X Walk2?	N/A
	X Walk 1 Direction	To S		X Walk 2 Direction	N/A
N/A	X Walk 1 Width (in)	N/A	N/A	X Walk 2 Width (in)	N/A
	X Walk 1 Slope (%)	2.9		X Walk 2 Slope (%)	N/A
	X Walk 1 X Slope (%)	3.1		X Walk 2 X Slope (%)	N/A
N/A	Ramp inside XWalk1?	N/A	N/A	Ramp inside XWalk2?	N/A

Road Slope (%)	N/A	N/A	Clear Space?	N/A
	Road X Slope (%)	N/A	N/A	Clear Space to XWalk (in)	N/A
N/A	Any Obstructions?	N/A	N/A	Storm Grate/Utility Hazard?	N/A
	Obstruction Type			Storm Grate/Utility Type	
		N/A			N/A
			Yes	Surface Condition? (G/P)	Good
			N/A	Curb Slope (%)	3.2

Possible Solutions:

Remove & Replace Entire Ramp.

Total Cost: \$ 1600.00
