# Access Compliance Report

## Public Rights-of-Way

| Intersection ID: 7610 | Main Street: NICOLET_GLEN_DR | Cross Street: TWEEDSMUIR_GLEN_LN | Location: SE |
| ADA ID: EDB7339B987B | Ramp Type: Directional | Initial Pass/Fail: Pass | Overall Compliance: No |

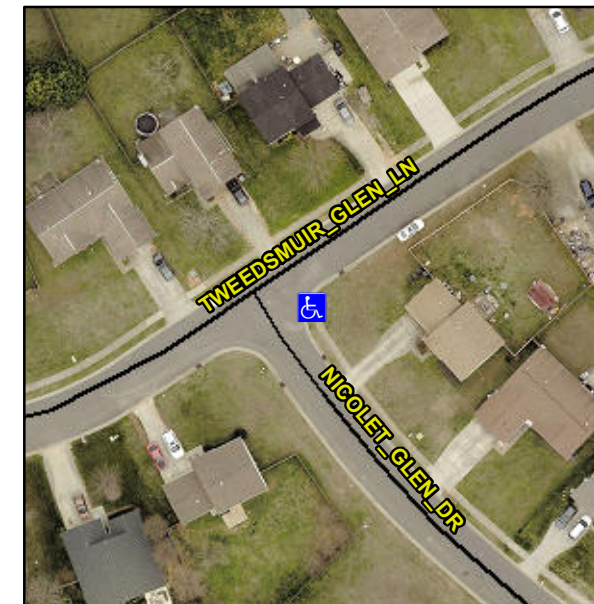
**CRACK LT FL**

**R304.2.1, R304.2.2-Perp, R304.3.2-  
Para, R304.5.3, R305, R304.5.4**

| Compliance | Description | Data | Compliance | Description | Data |
|---|---|---|---|---|---|
| Yes | Ramp Slope (%) | 6.3 | No | Grade Break XSlope (%) | 4.0 |
| No | Landing Width (in) | 47.0 | N/A | DWS Contrast? | No |
| No | Landing Slope (%) | 2.5 | N/A | DWS Length (in) | N/A |
| Yes | Gutter Ponding? | No | No | Gutter Slope (%) | 13.0 |

**Remove & Replace Entire Ramp.  
Remove & Replace Gutter.**
