# Access Compliance Report

## Public Rights-of-Way

### (Curb Ramps)

| Intersection ID: 10036734 | Main Street: S_DAVIDSON_ST | Cross Street: STONEWALL_ST | Location: NE |

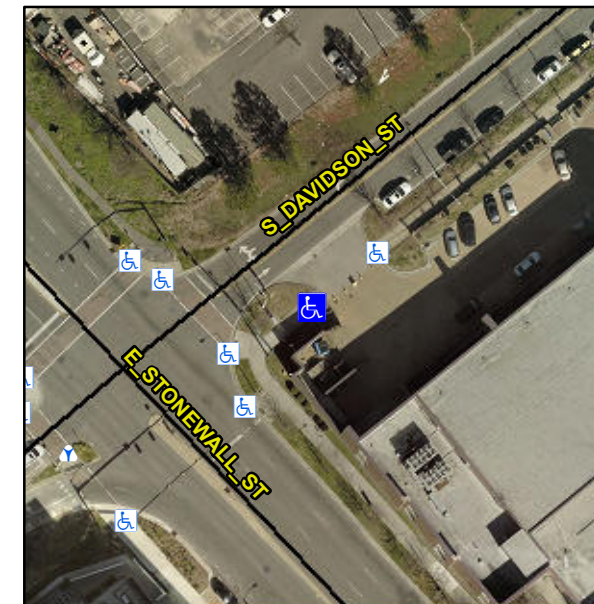
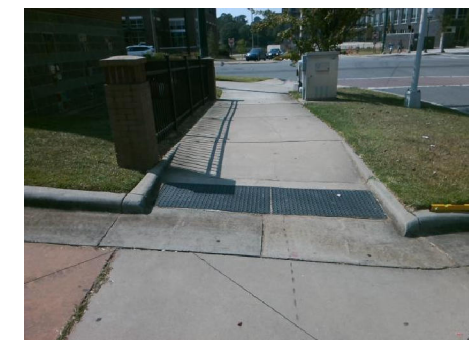
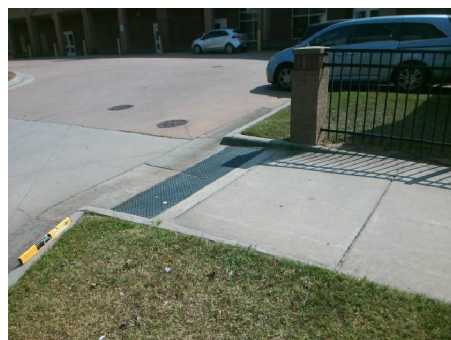
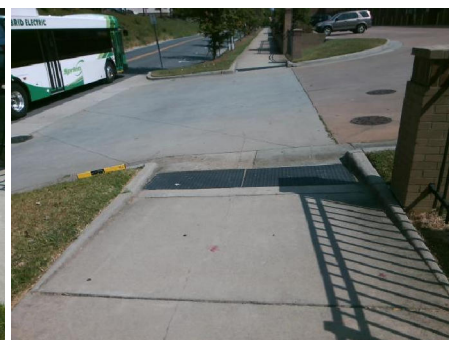
**R304.5.2**

| Compliance | Description | Data | Compliance | Description | Data |
|---|---|---|---|---|---|
| N/A | Ramp Length (in) | 96.0 | No | Grade Break? | No |

**Remove & Replace Entire Ramp.**

\$ 1600.00
