# Access Compliance Report

## Public Rights-of-Way

### (Curb Ramps)

Intersection ID: 15394	Main Street: HERMAN_AV	Cross Street: S_TRYON_ST	Location: NE
ADA ID: EDBC1051CA8E	Ramp Type: PerpDiag	Initial Pass/Fail: Fail	Overall Compliance: No
Severity Score: 25			
Codes/Mitigation Info/Possible Solution		Field Measurements/Component Compliance

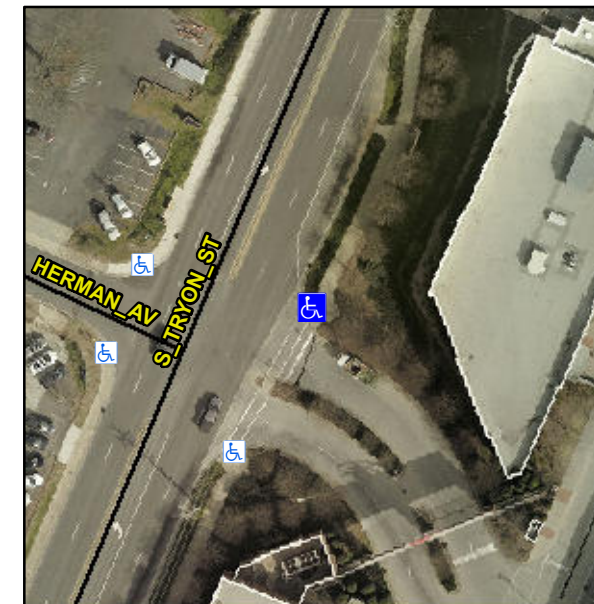
Compliance	Description	Data	Compliance	Description	Data
N/A	Ramp Length (in)	96.0	Yes	Ramp Slope (%)	7.8
Yes	Ramp Width (in)	50.0	No	Ramp XSlope (%)	8.7
N/A	Flare Type LT	N/A	N/A	Flare Type RT	N/A
N/A	Flare Slope LT (%)	N/A	N/A	Flare Slope RT (%)	N/A
N/A	Flare Traversable LT?	N/A	N/A	Flare Traversable RT?	N/A
N/A	Landing Length (in)	N/A	N/A	DWS Provided?	N/A
N/A	Landing Width (in)	N/A	N/A	DWS Contrast?	N/A
N/A	Landing Slope (%)	N/A	N/A	DWS Length (in)	N/A
N/A	Landing X Slope (%)	N/A	N/A	DWS Full Width?	N/A
N/A	Landing Curb? (Y/N)	N/A	N/A	DWS Offset (in)	N/A
N/A	Shared Landing?	N/A			
N/A	Gutter Ponding?	N/A	N/A	Gutter Slope (%)	N/A
N/A	Gutter Lip Ht (in)	N/A	N/A	Gutter X Slope (%)	N/A
N/A	Painted X Walk1?	No	N/A	Painted X Walk2?	Yes
	X Walk 1 Direction	To NW		X Walk 2 Direction	To SW
N/A	X Walk 1 Width (in)	N/A	N/A	X Walk 2 Width (in)	60.0
	X Walk 1 Slope (%)	9.3		X Walk 2 Slope (%)	4.6
	X Walk 1 X Slope (%)	2.1		X Walk 2 X Slope (%)	7.9

N/A	Ramp inside XWalk1?	N/A	N/A	Ramp inside XWalk2?	Yes
	Road Slope (%)	4.8	N/A	Clear Space?	N/A
	Road X Slope (%)	3.0	N/A	Clear Space to XWalk (in)	N/A
N/A	Any Obstructions?	N/A	N/A	Storm Grate/Utility Hazard?	N/A
	Obstruction Type			Storm Grate/Utility Type	
		N/A			N/A
		Yes		Surface Condition? (G/P)	Good

**Remove & Replace Curb Ramp With Two New Directional Ramps or Equivalent.**

**R304.5.3**

**\$ 3200.00**
