Access Compliance Report

Public Rights-of-Way

(Curb Ramps)

Intersection ID: 25272	Main Street: BRIDLE_BROOK_WY	Cross Street: MAYNARD_RD	Location:	N
ADA ID: EDC3AC78CDBF	Ramp Type: PerpDiag	Initial Pass/Fail: Fail	Overall Compliance: No	Severity Score: 10
Codes/Mitigation Info/Possible Solution		Field Measurements/Component Compliance

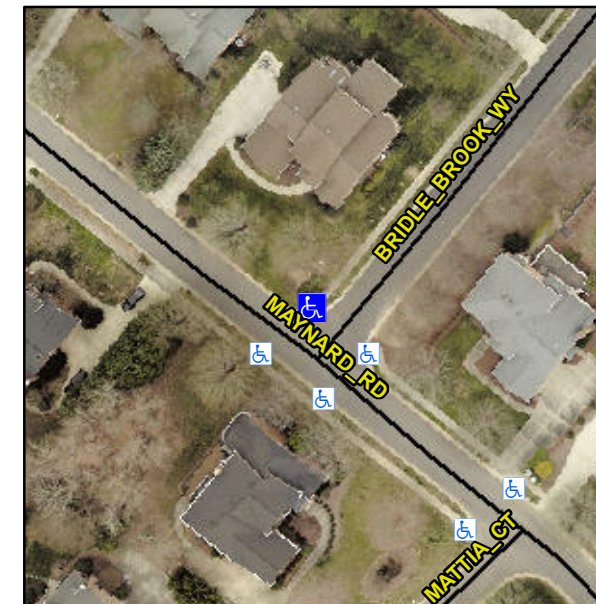
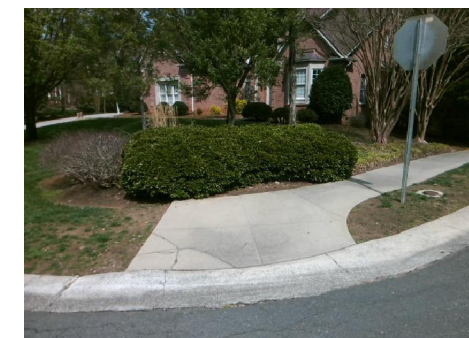
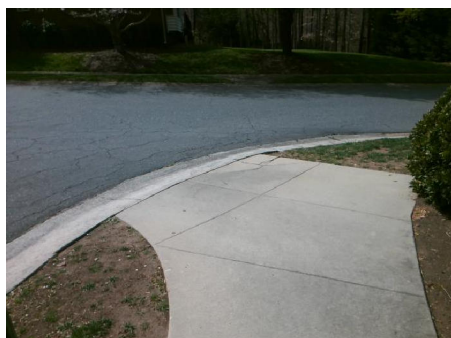
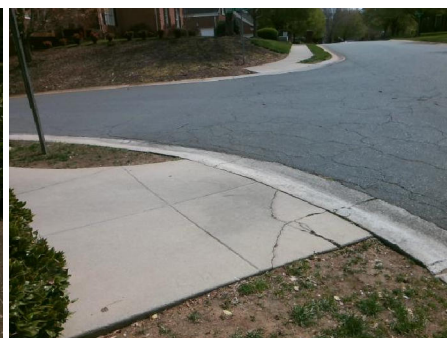
Not Found, R304.5.1, R304.5.3

Compliance	Description	Data	Compliance	Description	Data
N/A	Ramp Length (in)	96.0	Yes	Ramp Slope (%)	6.9
No	Ramp Width (in)	46.0	No	Ramp XSlope (%)	2.5
N/A	Flare Type LT	N/A	N/A	Flare Type RT	N/A
N/A	Flare Slope LT (%)	N/A	N/A	Flare Slope RT (%)	N/A
N/A	Flare Traversable LT?	N/A	N/A	Flare Traversable RT?	N/A
N/A	Landing Length (in)	N/A	N/A	DWS Provided?	N/A
N/A	Landing Width (in)	N/A	N/A	DWS Contrast?	N/A
N/A	Landing Slope (%)	N/A	N/A	DWS Length (in)	N/A
N/A	Landing X Slope (%)	N/A	N/A	DWS Full Width?	N/A
N/A	Landing Curb? (Y/N)	N/A	N/A	DWS Offset (in)	N/A
N/A	Shared Landing?	N/A			
N/A	Gutter Ponding?	N/A	N/A	Gutter Slope (%)	N/A
N/A	Gutter Lip Ht (in)	N/A	N/A	Gutter X Slope (%)	N/A
N/A	Painted X Walk1?	No	N/A	Painted X Walk2?	No
	X Walk 1 Direction	To SW		X Walk 2 Direction	To SE
N/A	X Walk 1 Width (in)	N/A	N/A	X Walk 2 Width (in)	N/A
	X Walk 1 Slope (%)	6.3		X Walk 2 Slope (%)	8.8
	X Walk 1 X Slope (%)	7.7		X Walk 2 X Slope (%)	1.8

N/A	Ramp inside XWalk1?	N/A	N/A	Ramp inside XWalk2?	N/A
	Road Slope (%)	5.7	N/A	Clear Space?	N/A
	Road X Slope (%)	8.0	N/A	Clear Space to XWalk (in)	N/A
N/A	Any Obstructions?	N/A	N/A	Storm Grate/Utility Hazard?	N/A
	Obstruction Type			Storm Grate/Utility Type	
		N/A			N/A
			Yes	Surface Condition? (G/P)	Good

Remove & Replace Curb Ramp With Two New Directional Ramps or Equivalent.
