Access Compliance Report Public Rights-of-Way (Curb Ramps)

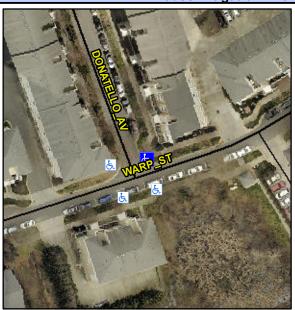
Intersection ID: 9783Main Street:WARP_STCross Street:DONATELLO_AVLocation:NEADA ID: EDC7E8DD30CFRamp Type:PerpDiagInitial Pass/Fail:FailOverall Compliance:NoSeverity Score:22.5

Not Found, R304.5.1, R304.2.2, R304.5.3

Field Measurements/Component Compliance					
Comp	liance Description	Data	Comp	liance Description	Data
N/A	Ramp Length (in)	57.0	No	Ramp Slope (%)	11.4
No	Ramp Width (in)	45.0	No	Ramp XSlope (%)	4.2
N/A	Flare Type LT	N/A	N/A	Flare Type RT	N/A
N/A	Flare Slope LT (%)	N/A	N/A	Flare Slope RT (%)	N/A
N/A	Flare Traversable LT?	N/A	N/A	Flare Traversable RT?	N/A
N/A	Landing Length (in)	N/A	N/A	DWS Provided?	N/A
N/A	Landing Width (in)	N/A	N/A	DWS Contrast?	N/A
N/A	Landing Slope (%)	N/A	N/A	DWS Length (in)	N/A
N/A	Landing X Slope (%)	N/A	N/A	DWS Full Width?	N/A
N/A	Landing Curb? (Y/N)	N/A	N/A	DWS Offset (in)	N/A
N/A	Shared Landing?	N/A			
N/A	Gutter Ponding?	N/A	N/A	Gutter Slope (%)	N/A
N/A	Gutter Lip Ht (in)	N/A	N/A	Gutter X Slope (%)	N/A
N/A	Painted X Walk1?	No	N/A	Painted X Walk2?	No
	X Walk 1 Direction	To W		X Walk 2 Direction	To S
N/A	X Walk 1 Width (in)	N/A	N/A	X Walk 2 Width (in)	N/A
	X Walk 1 Slope (%)	0.3		X Walk 2 Slope (%)	2.6

X Walk 1 X Slope (%)	1.9		X Walk 2 X Slope (%)	0.8
N/A	Ramp inside XWalk1?	N/A	N/A	Ramp inside XWalk2?	N/A
	Road Slope (%)	2.1	N/A	Clear Space?	N/A
	Road X Slope (%)	2.8	N/A	Clear Space to XWalk (in)	N/A
N/A	Any Obstructions?	N/A	N/A	Storm Grate/Utility Hazard?	N/A
	Obstruction Type			Storm Grate/Utility Type	
		N/A			N/A
			Yes	Surface Condition? (G/P)	Good
No. 17 - A	The state of the s

Remove & Replace Curb Ramp With Two New Directional Ramps or Equivalent.
