# Access Compliance Report

## Public Rights-of-Way

### (Curb Ramps)

| Intersection ID: 6481 | Main Street: LOTHAR RIDGE LN | Cross Street: SLATER SPRINGS DR | Location: NE |

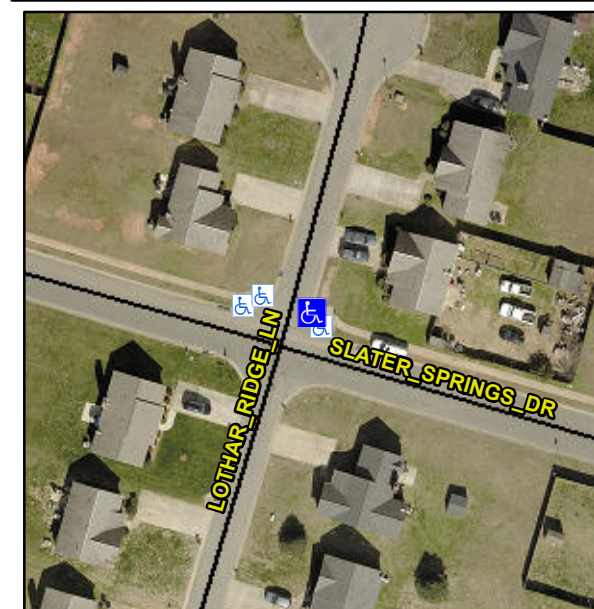
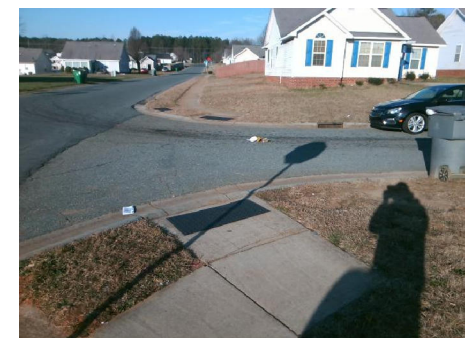
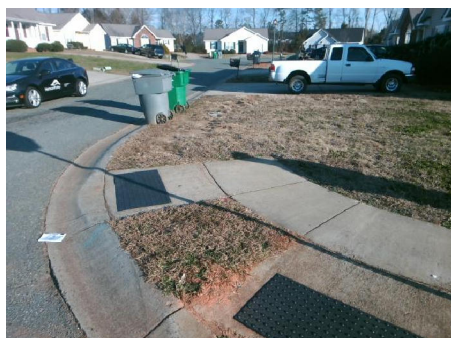
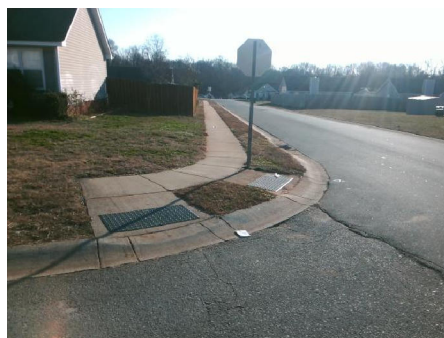
**NO LT SW**

**Not Found, R304.5.1, R304.5.3**

| Compliance | Description | Data | Compliance | Description | Data |
|---|---|---|---|---|---|
| No | Ramp Width (in) | 38.0 | No | BlendTrans XSlope (%) | 5.1 |
| | | | No | Curb Slope (%) | 20.9 |

**Remove & Replace Curb Ramp With Two New Directional Ramps or Equivalent.**

Total Cost: \$ 3200.00
