Access Compliance Report

Public Rights-of-Way

(Curb Ramps)

Intersection ID: 47691	Main Street: GLENOLDEN_DR	Cross Street: GREEN_PASTURE_RD	Location: W
ADA ID: EDD1A9270C8B	Ramp Type: Perp	Initial Pass/Fail: Fail	Overall Compliance: No
Severity Score: 12.5			
Codes/Mitigation Info/Possible Solution		Field Measurements/Component Compliance

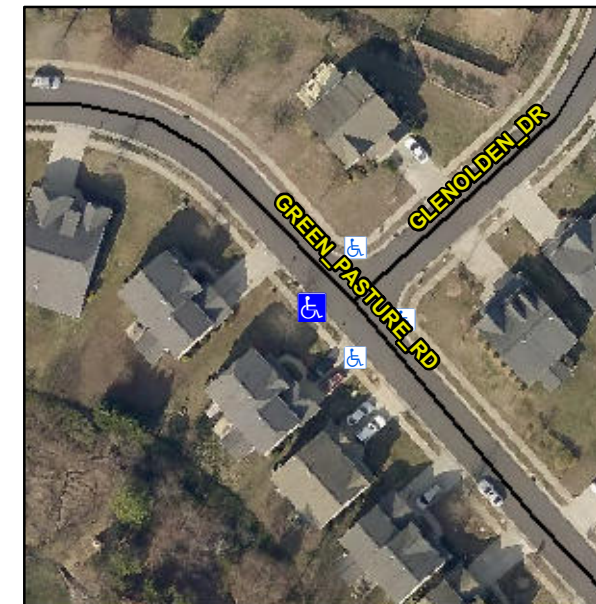
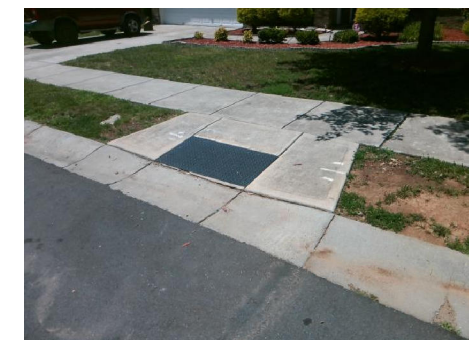
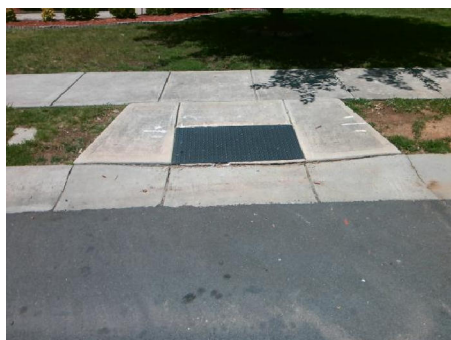
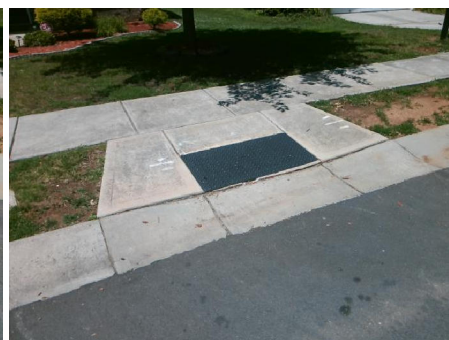
Not Found, R304.2.2

Compliance	Description	Data	Compliance	Description	Data
N/A	Ramp Length (in)	48.0	No	Ramp Slope (%)	11.6
Yes	Ramp Width (in)	48.0	Yes	Ramp XSlope (%)	1.4
N/A	Flare Type LT	N/A	N/A	Flare Type RT	N/A
N/A	Flare Slope LT (%)	N/A	N/A	Flare Slope RT (%)	N/A
N/A	Flare Traversable LT?	N/A	N/A	Flare Traversable RT?	N/A
N/A	Landing Length (in)	N/A	N/A	DWS Provided?	N/A
N/A	Landing Width (in)	N/A	N/A	DWS Contrast?	N/A
N/A	Landing Slope (%)	N/A	N/A	DWS Length (in)	N/A
N/A	Landing X Slope (%)	N/A	N/A	DWS Full Width?	N/A
N/A	Landing Curb? (Y/N)	N/A	N/A	DWS Offset (in)	N/A
N/A	Shared Landing?	N/A			
N/A	Gutter Ponding?	N/A	N/A	Gutter Slope (%)	N/A
N/A	Gutter Lip Ht (in)	1.0	N/A	Gutter X Slope (%)	N/A
N/A	Painted X Walk1?	No	N/A	Painted X Walk2?	N/A
	X Walk 1 Direction	To NE		X Walk 2 Direction	N/A
N/A	X Walk 1 Width (in)	N/A	N/A	X Walk 2 Width (in)	N/A
	X Walk 1 Slope (%)	2.8		X Walk 2 Slope (%)	N/A
	X Walk 1 X Slope (%)	2.7		X Walk 2 X Slope (%)	N/A

N/A	Ramp inside XWalk1?	N/A	N/A	Ramp inside XWalk2?	N/A
	Road Slope (%)	N/A	N/A	Clear Space?	N/A
	Road X Slope (%)	N/A	N/A	Clear Space to XWalk (in)	N/A
N/A	Any Obstructions?	N/A	N/A	Storm Grate/Utility Hazard?	N/A
	Obstruction Type			Storm Grate/Utility Type	
		N/A			N/A
			Yes	Surface Condition? (G/P)	Good

Possible Solutions:

Remove & Replace Entire Ramp.
